Home Report

First Floor Left
236 Victoria Road
Aberdeen
AB11 9NS

Single Survey and Mortgage Valuation Report

Property address	First Floor Left 236 Victoria Road Aberdeen AB11 9NS
Customer	Mr T Hicks
Customer address	236 Victoria Road Aberdeen AB11 9NS
Prepared by	ALLIED SURVEYORS SCOTLAND PLC
Date of inspection	9th October 2020

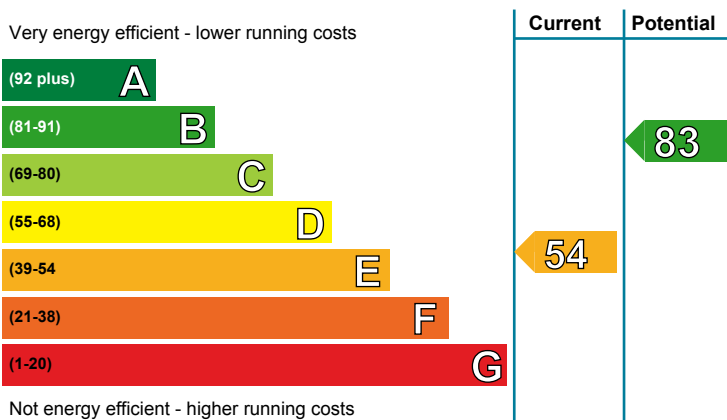
Energy Efficiency Rating

This graph shows the current efficiency of your home, taking into account both energy efficiency and fuel costs. The higher this rating, the lower your fuel bills are likely to be.

Your current rating is **band E (54)**. The average rating for EPCs in Scotland is **band D (61)**.

The potential rating shows the effect of undertaking all of the improvement measures listed within your recommendations report.
