Home Report

Property: **158
West High Street
Leven
Fife
KY8 1AN**

Report reference: **1061207-1-2**

Date of Report: **20/10/2020**

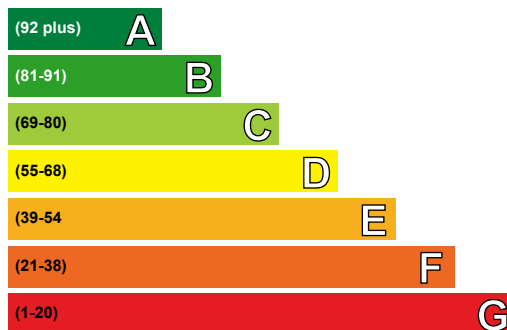
Energy Efficiency Rating

Current	Potential
70	86

This graph shows the current efficiency of your home, taking into account both energy efficiency and fuel costs. The higher this rating, the lower your fuel bills are likely to be.

The potential rating shows the effect of undertaking all of the improvement measures listed within your recommendations report.

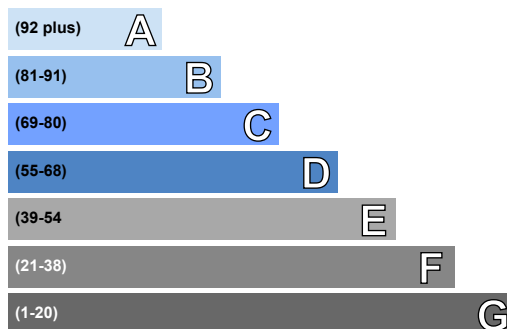
Environmental Impact (CO₂) Rating

Current	Potential
69	85

The potential rating shows the effect of undertaking all of the improvement measures listed within your recommendations report.

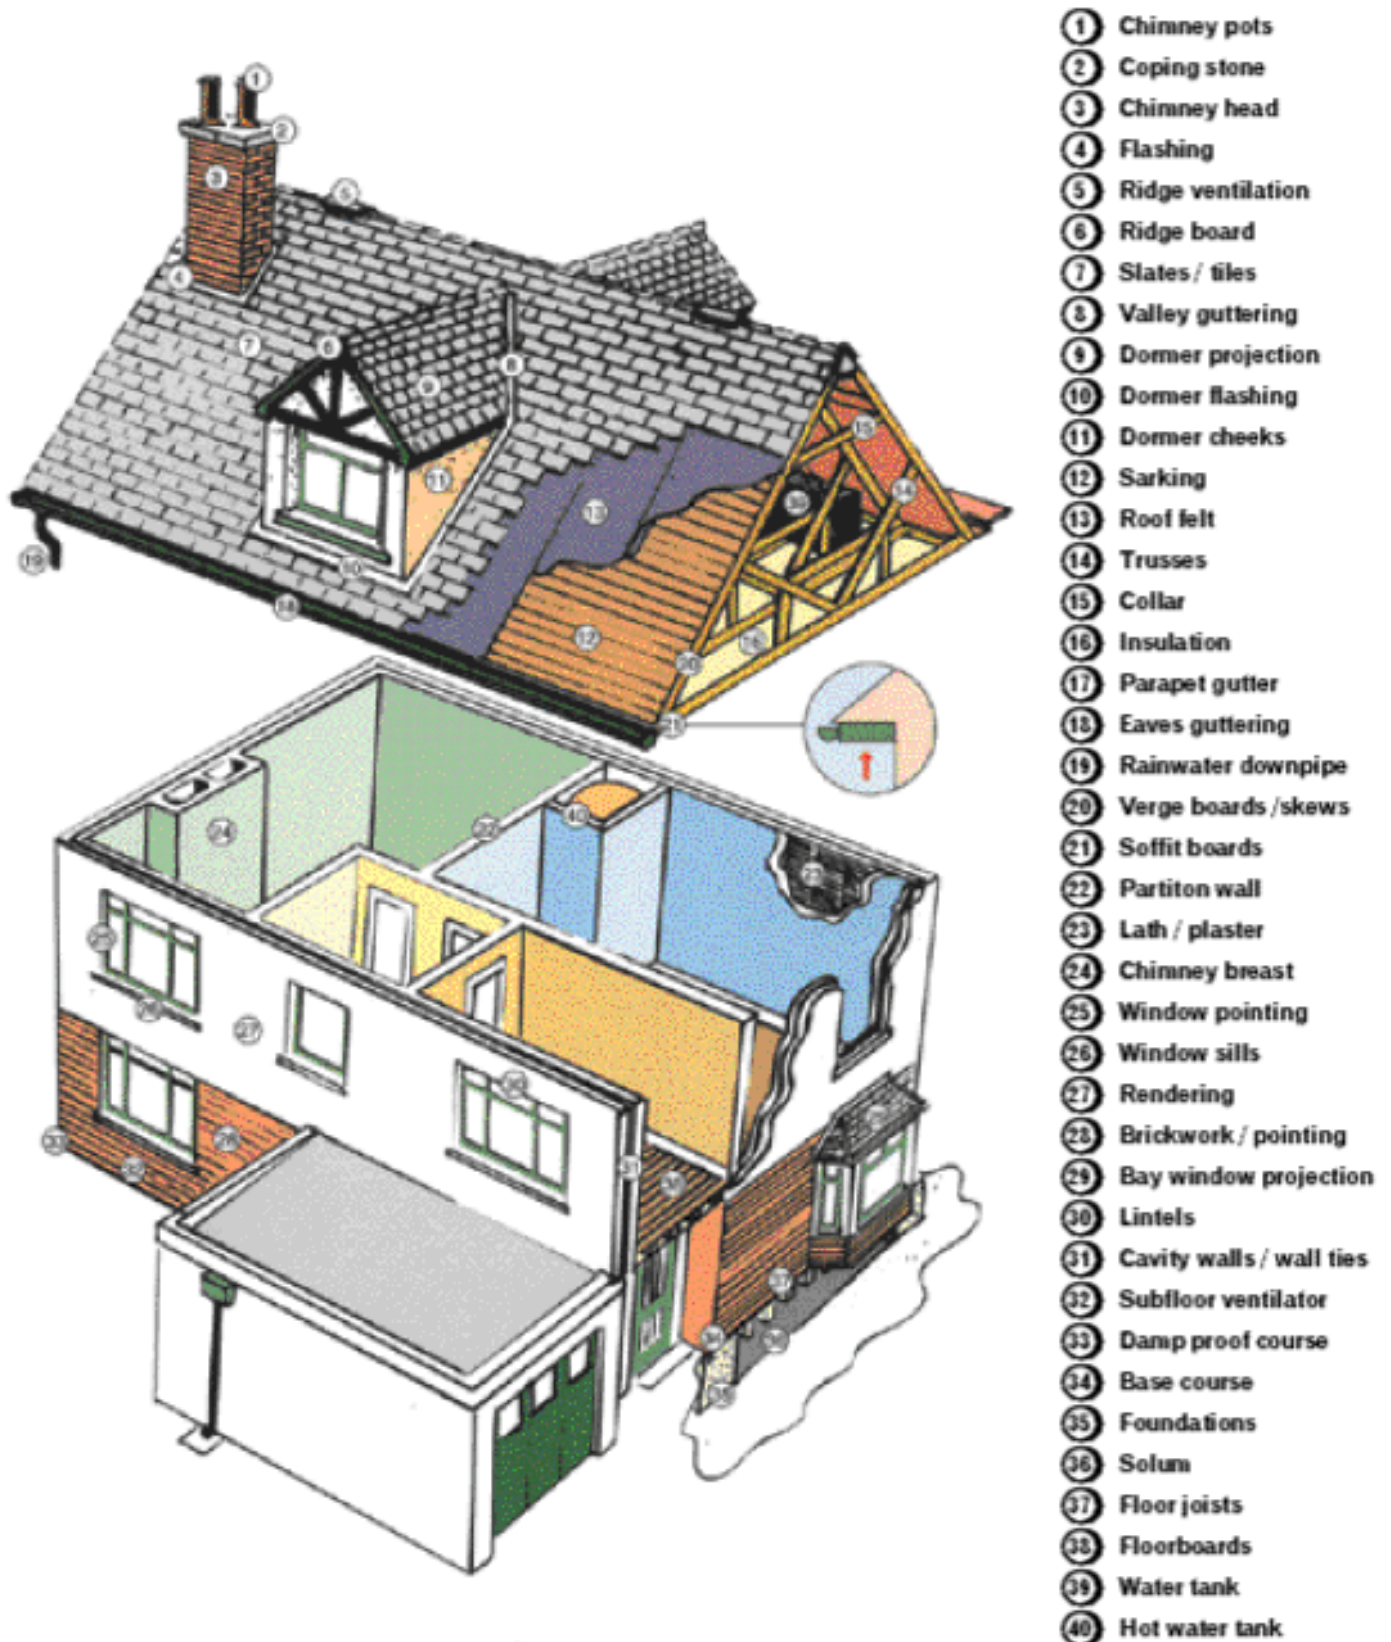
▷ Sectional diagram showing elements of a typical house:

Reference may be made in this report to some or all of the above component parts of the property. This diagram may assist you in locating and understanding these terms.
