HOME REPORT

FLAT 0/1 500 SHIELDHALL ROAD GLASGOW G51 4HE

survey report on:

Property address	FLAT 0/1 500 SHIELDHALL ROAD GLASGOW G51 4HE
Customer	Mr Paul McKinney & Mrs Allison McKinney
Customer address	Flat 0/1 500 Shieldhall Road Govan Glasgow G51 4HE
Prepared by	DM Hall LLP
Date of inspection	21st April 2021

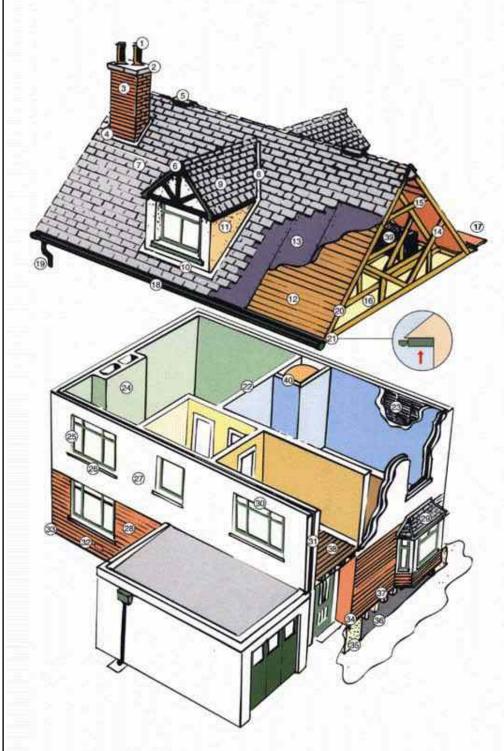
Sectional Diagram showing elements of a typical house

Reference may be made in this report to some or all of the above component parts of the property. This diagram may assist you in locating and understanding these items.

- 1 Chimney pots
- 2) Coping stone
- 3) Chimney head
- 4) Flashing
- (5) Ridge ventilation
- 6) Ridge board
- 7) Slates / tiles
- 8 Valley guttering
- 9) Dormer projection
- 10 Dormer flashing
- 11) Dormer cheeks
- (12) Sarking
- 13) Roof felt
- (14) Trusses
- 15) Collar
- (16) Insulation
- 17) Parapet gutter
- 18) Eaves guttering
- 19) Rainwater downpipe
- Verge boards /skews
- (21) Soffit boards
- (22) Partition wall
- 23 Lath / plaster
- 24) Chimney breast
- 25) Window pointing
- (6) Window sills
- (27) Rendering
- (28) Brickwork / pointing
- (29) Bay window projection
- (30) Lintels
- (31) Cavity walls / wall ties
- 32) Subfloor ventilator
- 33) Damp proof course
- 34) Base course
- 35) Foundations
- 36) Solum
- 37) Floor joists
- 38) Floorboards
- 9) Water tank
- 40) Hot water tank
