# Home Report

# Scottish Single Survey

| Property address | 71 London Road<br>Kilmarnock<br>KA3 7BP |
| Date of inspection | 29/09/2025 |

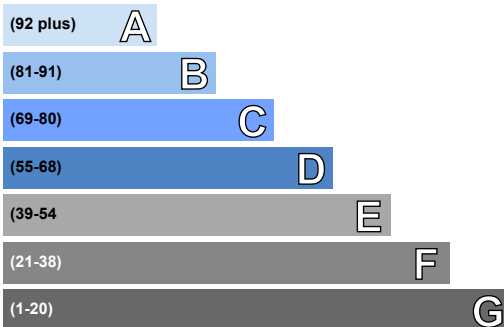
The potential rating shows the effect of undertaking all of the improvement measures listed within your recommendations report.

Very environmentally friendly - lower CO<sub>2</sub> emissions

Not environmentally friendly - higher CO<sub>2</sub> emissions
