# Home Report

Property: **3  
Knockhall Way  
Ellon  
Aberdeenshire  
AB41 6DN**

# Energy Performance Certificate (EPC)

## Schedule 1

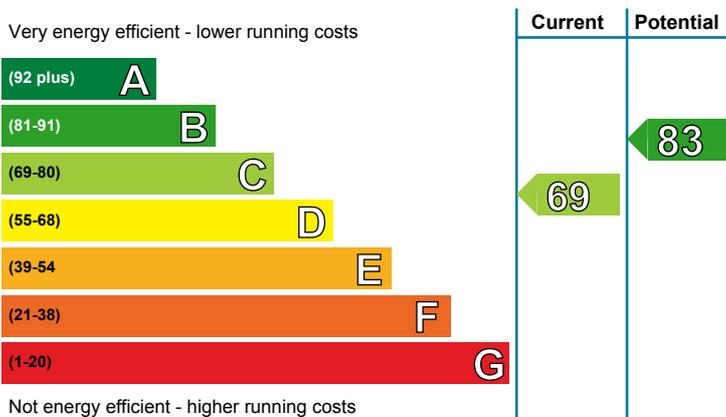
## Energy Efficiency Rating

This graph shows the current efficiency of your home, taking into account both energy efficiency and fuel costs. The higher this rating, the lower your fuel bills are likely to be.

Your current rating is **band C (69)**. The average rating for EPCs in Scotland is **band D (61)**.

The potential rating shows the effect of undertaking all of the improvement measures listed within your recommendations report.

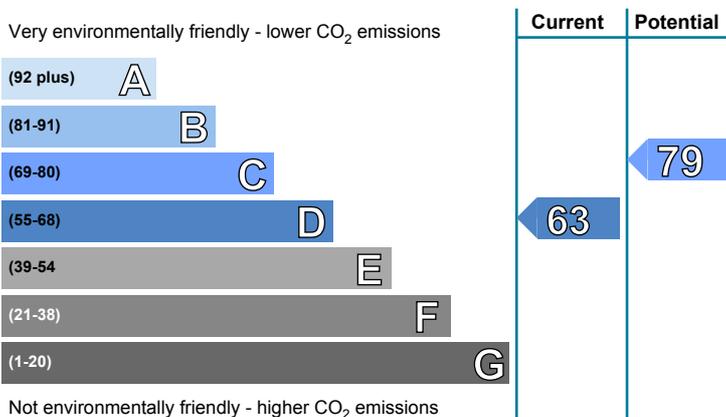
## Environmental Impact (CO<sub>2</sub>) Rating

This graph shows the effect of your home on the environment in terms of carbon dioxide (CO<sub>2</sub>) emissions. The higher the rating, the less impact it has on the environment.

The potential rating shows the effect of undertaking all of the improvement measures listed within your recommendations report.

The average Scottish household produces about 6 tonnes of carbon dioxide every year. Based on this assessment, heating and lighting this home currently produces approximately 5.6 tonnes of carbon dioxide every year. Adopting recommendations in this report can reduce emissions and protect the environment. If you were to install all of these recommendations this could reduce emissions by 2.2 tonnes per year. You could reduce emissions even more by switching to renewable energy sources.
