Home Report

Scottish
Single Survey

Property address	Flat H 2 Dunlop Terrace Ayr KA8 0SP
	KAO USP
Customer	Mr K Smith
Customer address	Flat H 2 Dunlop Terrace Ayr KA8 0SP
Prepared by	Shepherd Chartered Surveyors
Date of inspection	18/02/2025

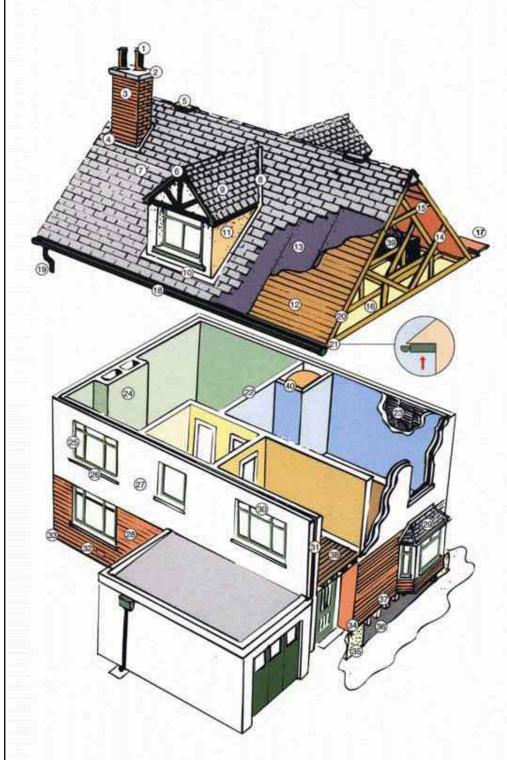
Sectional Diagram showing elements of a typical house

Reference may be made in this report to some or all of the above component parts of the property. This diagram may assist you in locating and understanding these items.

- 1) Chimney pots
- 2) Coping stone
- 3) Chimney head
- (4) Flashing
- 5) Ridge ventilation
- 6 Ridge board
- 7 Slates / tiles
- 8 Valley guttering
- 9 Dormer projection
- 10 Dormer flashing
- 11) Dormer cheeks
- (12) Sarking
- 13) Roof felt
- (14) Trusses
- (15) Collar
- (16) Insulation
- 17) Parapet gutter
- 18) Eaves guttering
- (19) Rainwater downpipe
- 20) Verge boards/skews
- 21) Soffit boards
- 22) Partition wall
- 23) Lath / plaster
- 24) Chimney breast
- (25) Window pointing
- 26) Window sills
- 27) Rendering
- 28) Brickwork / pointing
- 29) Bay window projection
- (30) Lintels
- (31) Cavity walls / wall ties
- 32) Subfloor ventilator
- (33) Damp proof course
- 34) Base course
- 35) Foundations
- 36) Solum
- 7) Floor joists
- 38) Floorboards
- 39) Water tank
- 40) Hot water tank
