# Single Survey

<b>Property Address</b>	16 Marchfield Quadrant Ayr Ayrshire KA8 8PE
<b>Customer</b>	Ms R Wilman C/O AMGGU
<b>Date of Inspection</b>	27/06/2025
<b>Prepared by</b>	C Mitchell Connells Survey & Valuation Ltd

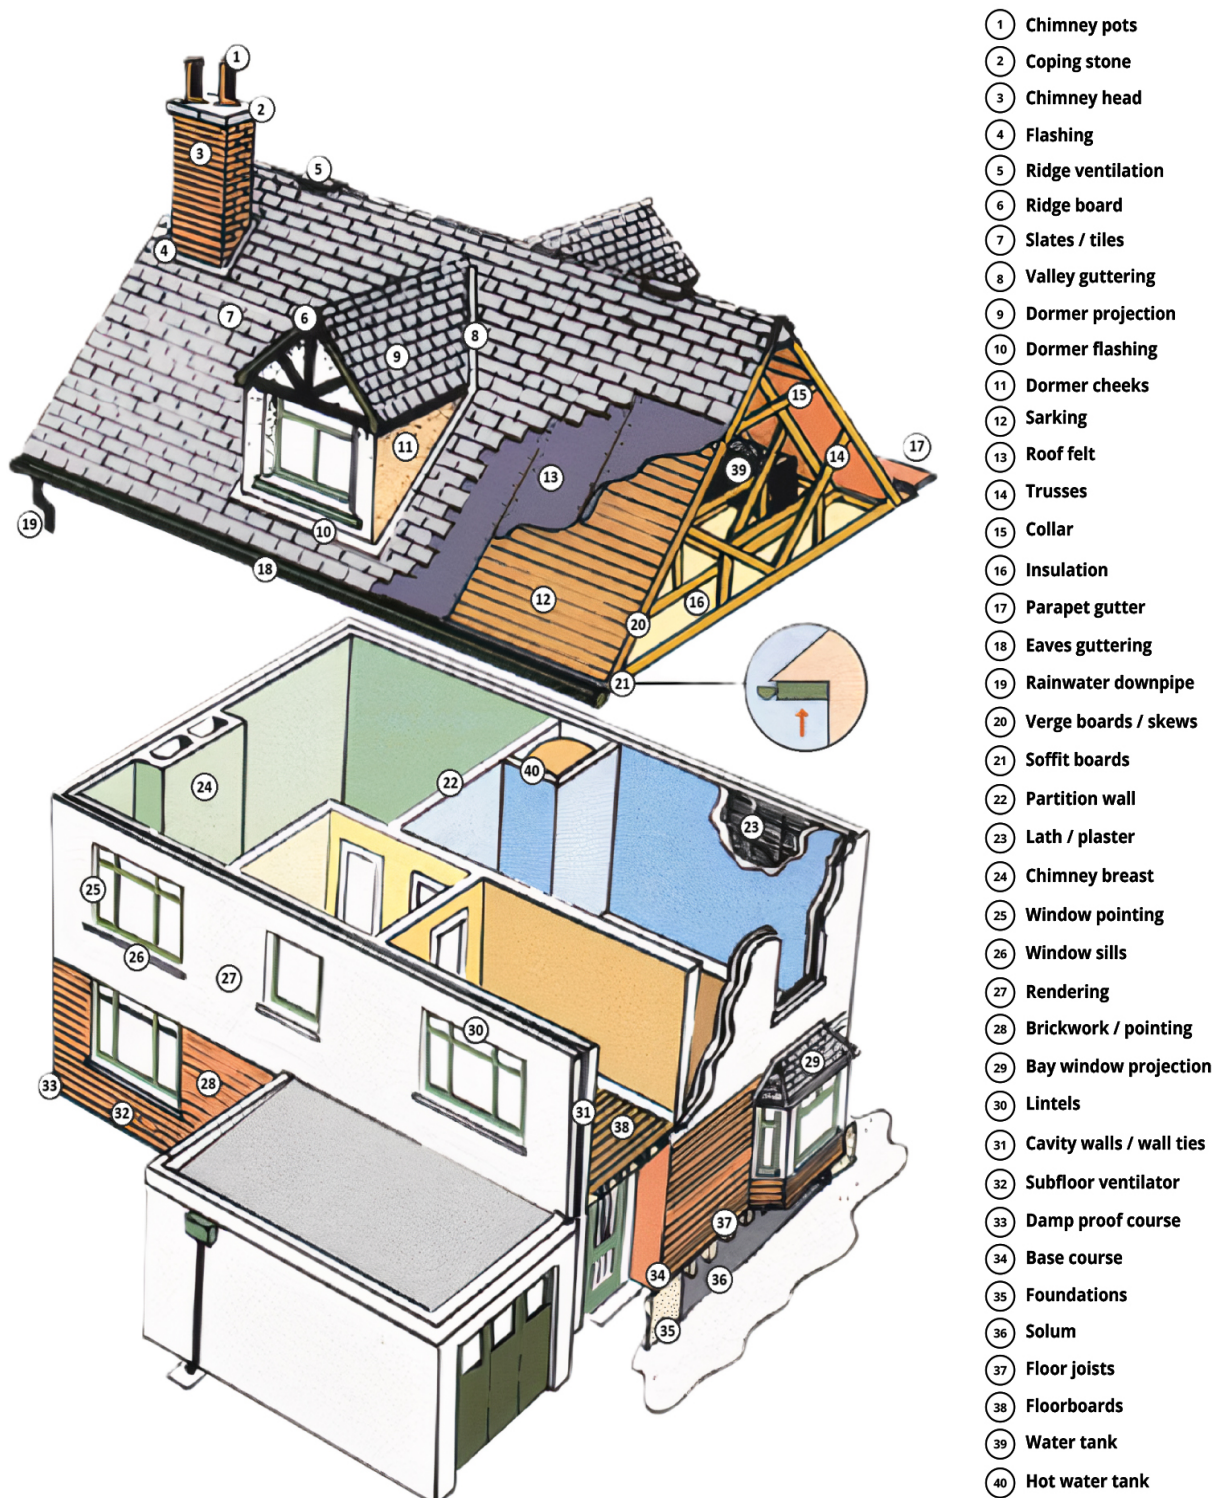
## Sectional Diagram showing elements of a typical house

Reference may be made in this report to some or all of the above component parts of the property. This diagram may assist you in locating and understanding these items.
