44 Maggie Woods Loan,  
Falkirk,  
Stirlingshire,  
FK1 5HR

# Home Report

# Single Survey

<b>Property Address</b>	44 Maggie Woods Loan, Falkirk, Stirlingshire, FK1 5HR
<b>Reference</b>	1018852
<b>Customer Name</b>	Mark Snedden
<b>Date of Inspection</b>	11th April 2025
<b>Surveyor's name, qualifications and office</b>	David Telford  DM Hall LLP Chartered Surveyors Unit 6A, The Courtyard Callendar Business Park Falkirk FK1 1XR  Tel: 01324 628321  email: <a href="mailto:centralresidential@dmhall.co.uk">centralresidential@dmhall.co.uk</a>
<b>Prepared By</b>	DM Hall LLP

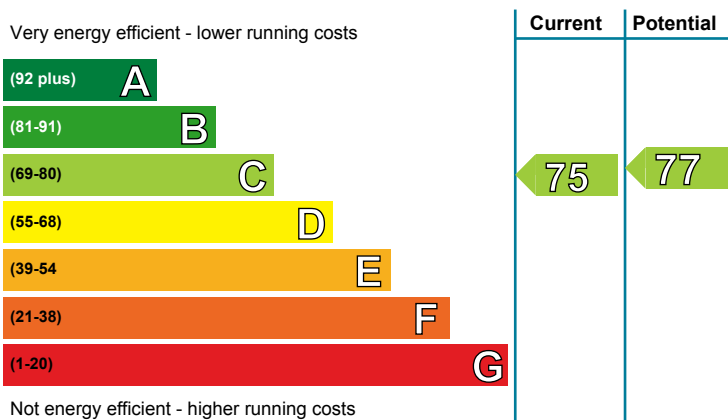
## Energy Efficiency Rating

This graph shows the current efficiency of your home, taking into account both energy efficiency and fuel costs. The higher this rating, the lower your fuel bills are likely to be.

Your current rating is **band C (75)**. The average rating for EPCs in Scotland is **band D (61)**.

The potential rating shows the effect of undertaking all of the improvement measures listed within your recommendations report.
