# Home Report

# Single Survey

## Survey Report on:

89 Bryce Avenue,  
Carron,  
Falkirk,  
Stirlingshire,  
FK2 8JB

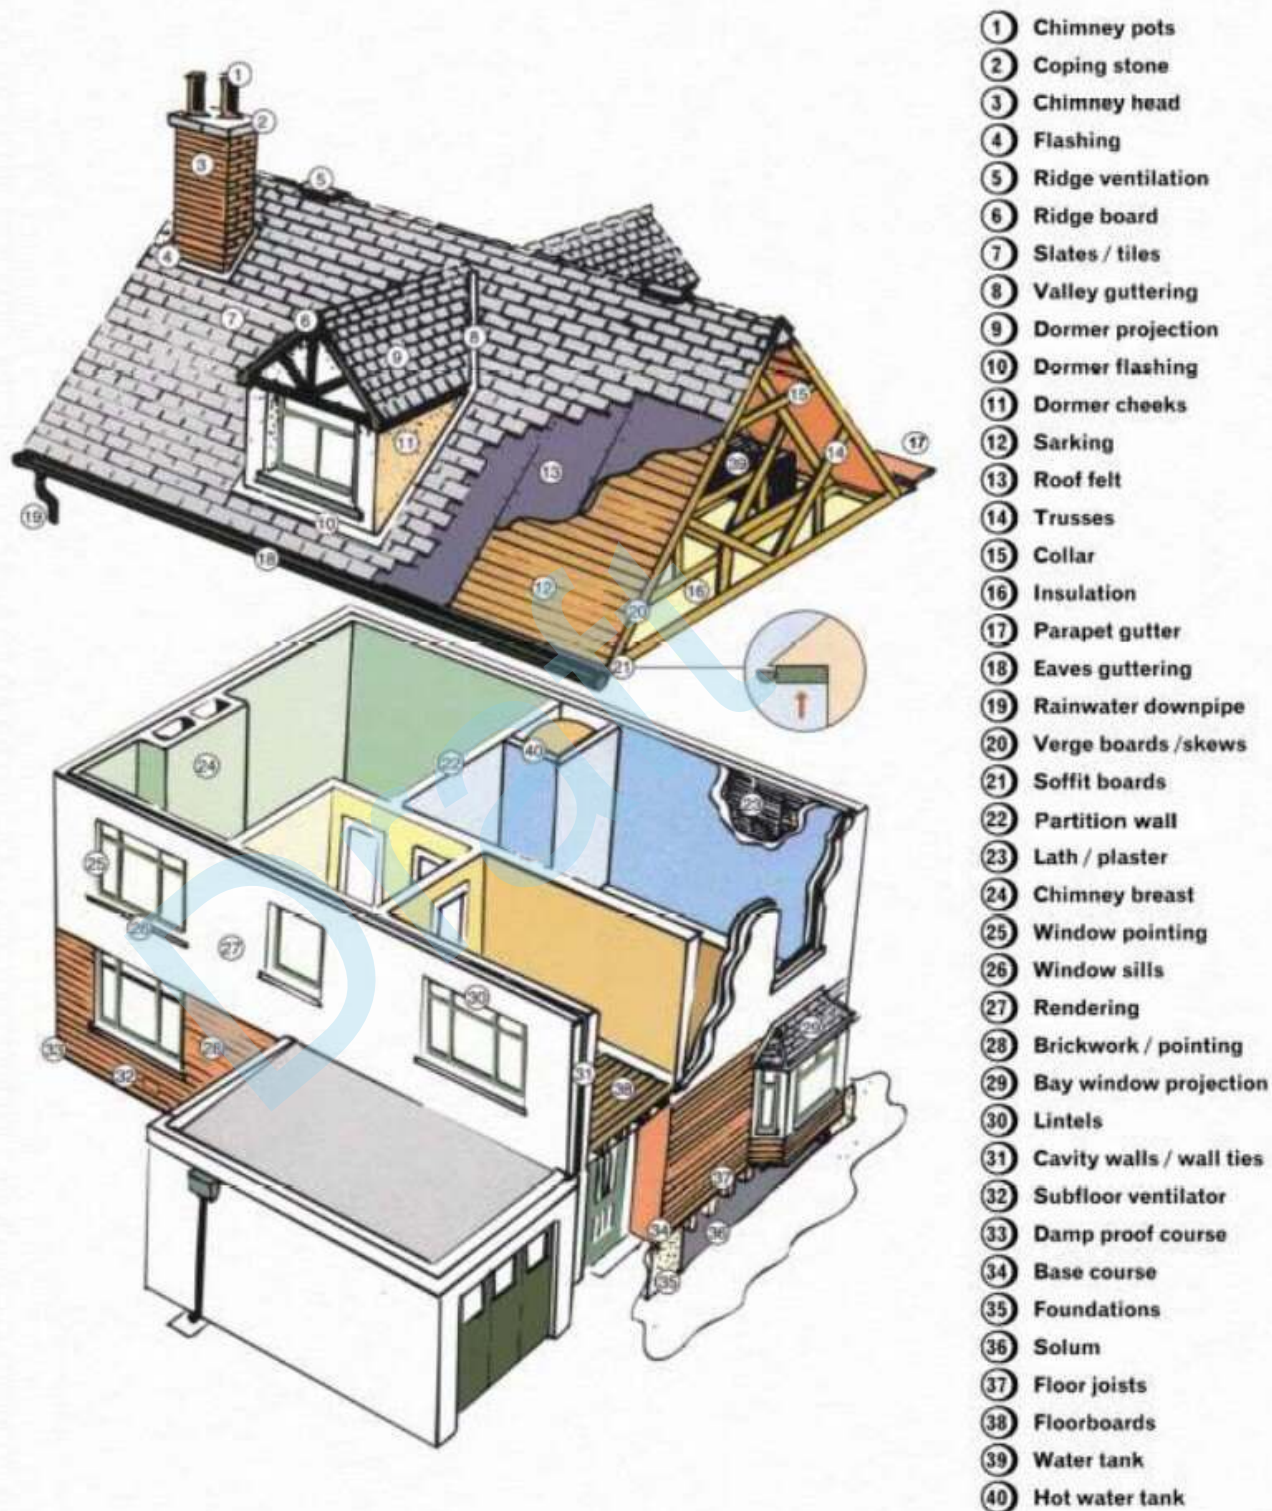
## Sectional Diagram showing elements of a typical house

Reference may be made in this report to some or all of the above component parts of the property. This diagram may assist you in locating and understanding these items.
