Garden Cottage, Foredale Terrace, Boness, EH51 9LW

Home Report

Single Survey

Property Address	Garden Cottage, Foredale Terrace, Boness, EH51 9LW
Reference	1032908
	•
Customer Name	Fraser Allan
Date of Inspection	25th April 2025
Surveyor's name, qualifications and office	Stephen Thomson
Office	DM Hall LLP Chartered Surveyors Unit 6A, The Courtyard Callendar Business Park Falkirk FK1 1XR
	Tel: 01324 628321

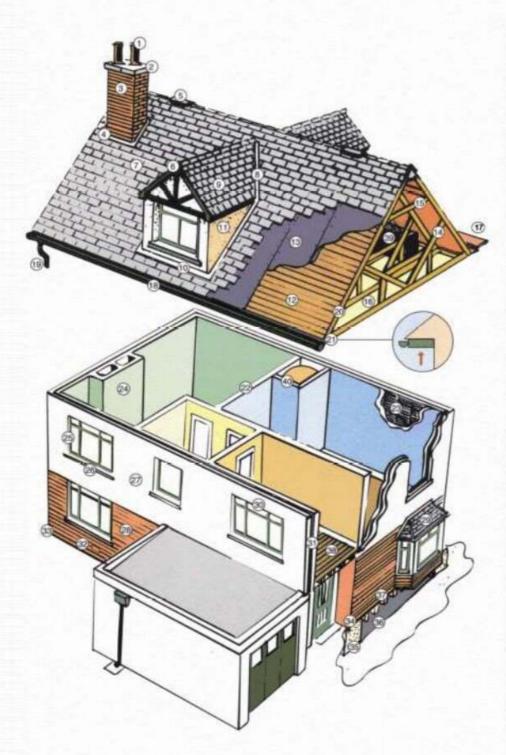
Sectional Diagram showing elements of a typical house

Reference may be made in this report to some or all of the above component parts of the property. This diagram may assist you in locating and understanding these items.

- 1) Chimney pots
- (2) Coping stone
- 3) Chimney head
- (4) Flashing
- (5) Ridge ventilation
- (6) Ridge board
- 7 Slates / tiles
- (8) Valley guttering
- 9 Dormer projection
- 10 Dormer flashing
- 11) Dormer cheeks
- 12) Sarking
- (13) Roof felt
- (14) Trusses
- (15) Collar
- (16) Insulation
- (17) Parapet gutter
- <u></u>
- 18) Eaves guttering
- (19) Rainwater downpipe (20) Verge boards /skews
- 21) Soffit boards
- 22) Partition wall
- (23) Lath / plaster
- (24) Chimney breast
- (25) Window pointing
- (26) Window sills
- (27) Rendering
- (28) Brickwork / pointing
- (29) Bay window projection
- (30) Lintels
- (31) Cavity walls / wall ties
- (32) Subfloor ventilator
- (33) Damp proof course
- 34) Base course
- 35 Foundations
- 36) Solum
- (37) Floor joists
- 38) Floorboards
- 39 Water tank
- 40) Hot water tank
