Home Report

67 Longdales Avenue,
Falkirk,
Stirlingshire,
FK2 7HZ

Single Survey

Survey Report on:

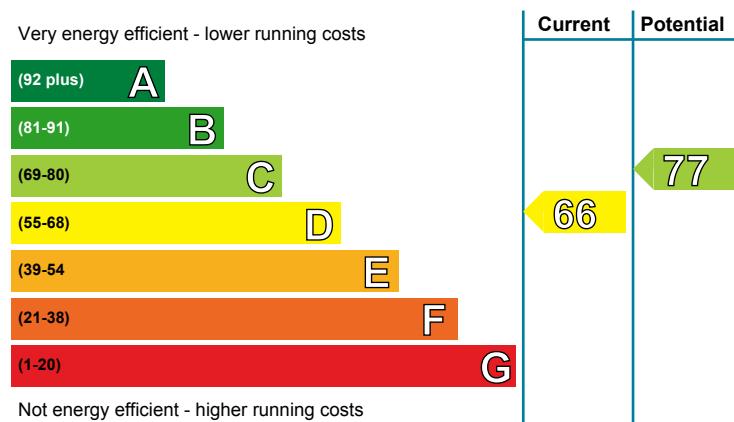
Energy Efficiency Rating

This graph shows the current efficiency of your home, taking into account both energy efficiency and fuel costs. The higher this rating, the lower your fuel bills are likely to be.

Your current rating is **band D (66)**. The average rating for EPCs in Scotland is **band D (61)**.

The potential rating shows the effect of undertaking all of the improvement measures listed within your recommendations report.

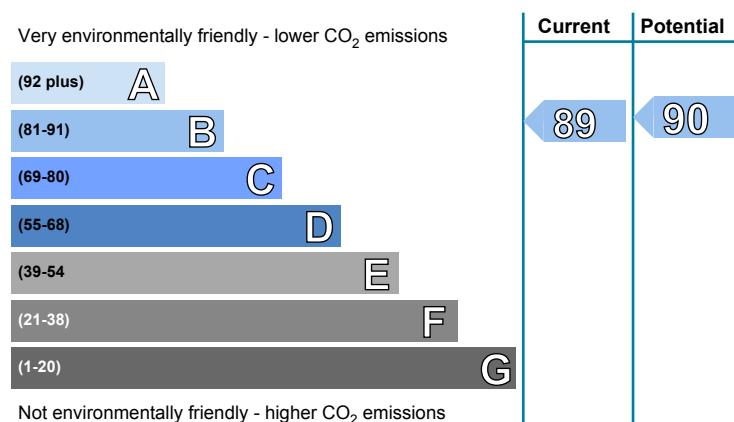
Environmental Impact (CO₂) Rating

This graph shows the effect of your home on the environment in terms of carbon dioxide (CO₂) emissions. The higher the rating, the less impact it has on the environment.
