Home Report

47 Fifth Avenue Glasgow G12 0AR

single survey

Property address	
,	47 Fifth Avenue
	Glasgow
	G12 OAR

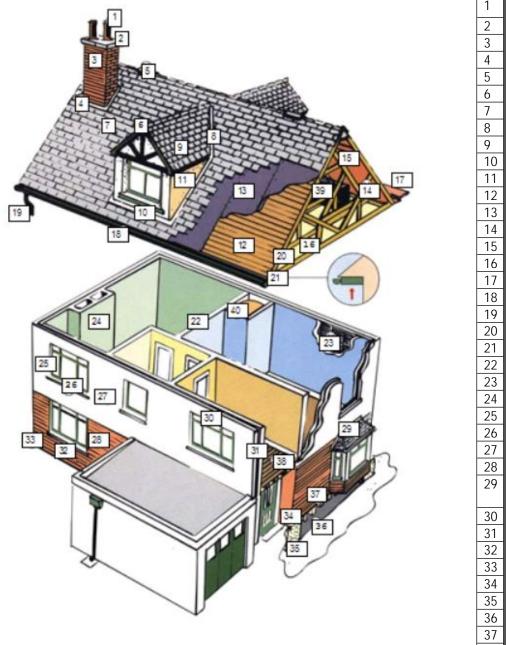
Sectional Diagram showing elements of a typical house

Reference may be made in this report to some or all of the above component parts of the property. This diagram may assist you in locating and understanding these items.
