Home Report

Scottish Single Survey

Property address	2/2 100 Lancefield Quay Glasgow G3 8HF
Customer	Calum Mcalinden
Customer address	2/2 100 Lancefield Quay Glasgow G3 8HF
Prepared by	Shepherd Chartered Surveyors
Date of inspection	14/05/2024

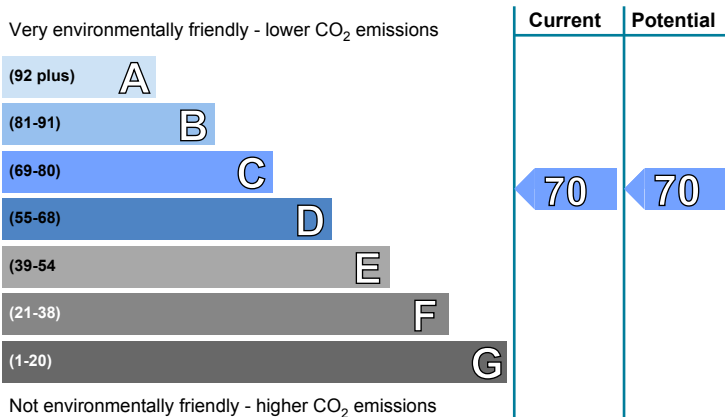
Environmental Impact (CO₂) Rating

This graph shows the effect of your home on the environment in terms of carbon dioxide (CO₂) emissions. The higher the rating, the less impact it has on the environment.
