# HOME REPORT

West Courtyard  
Balado  
KINROSS  
KY13 0NJ

# Single Survey

<b>Property address</b>	West Courtyard, Balado, KINROSS, KY13 0NJ
-------------------------	--

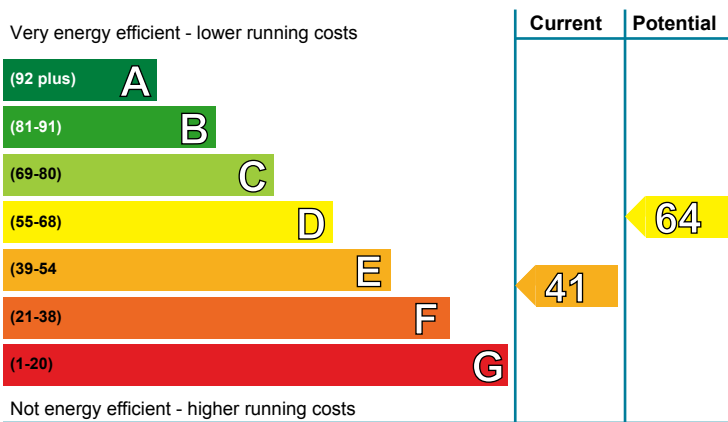
## Energy Efficiency Rating

This graph shows the current efficiency of your home, taking into account both energy efficiency and fuel costs. The higher this rating, the lower your fuel bills are likely to be.

Your current rating is **band E (41)**. The average rating for EPCs in Scotland is **band D (61)**.

The potential rating shows the effect of undertaking all of the improvement measures listed within your recommendations report.

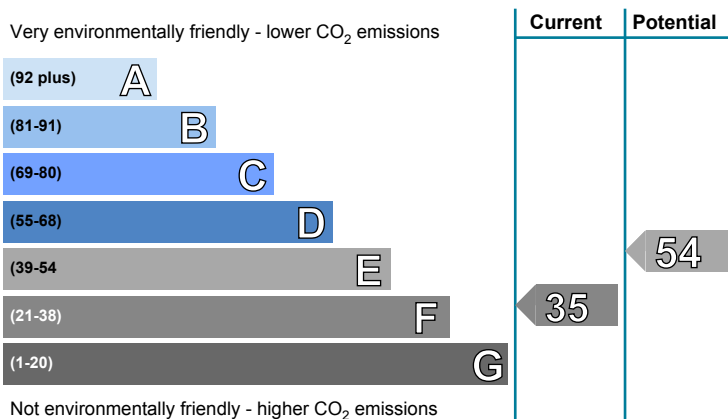
## Environmental Impact (CO<sub>2</sub>) Rating

This graph shows the effect of your home on the environment in terms of carbon dioxide (CO<sub>2</sub>) emissions. The higher the rating, the less impact it has on the environment.
