HOME REPORT

Dunhoy
Main Street
Kinnesswood
Kinross
KY13 9HN

DM HALL
CHARTERED SURVEYORS

Single Survey

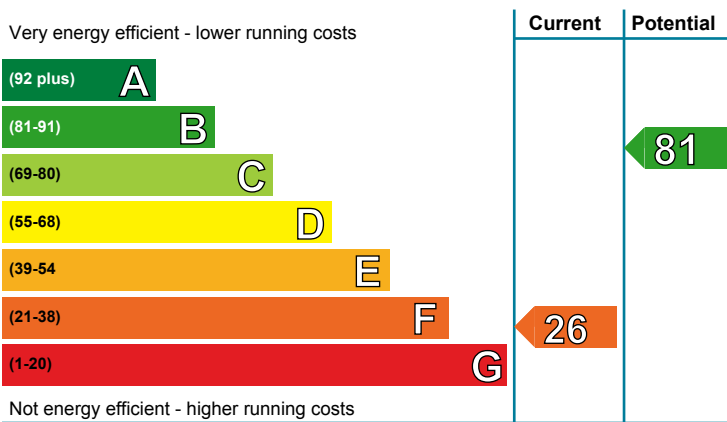
Energy Efficiency Rating

This graph shows the current efficiency of your home, taking into account both energy efficiency and fuel costs. The higher this rating, the lower your fuel bills are likely to be.

Your current rating is **band F (26)**. The average rating for EPCs in Scotland is **band D (61)**.

The potential rating shows the effect of undertaking all of the improvement measures listed within your recommendations report.

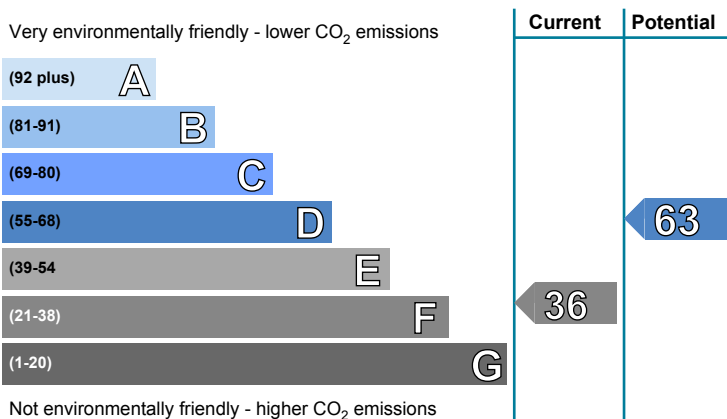
Environmental Impact (CO₂) Rating

This graph shows the effect of your home on the environment in terms of carbon dioxide (CO₂) emissions. The higher the rating, the less impact it has on the environment.
