HOME REPORT

19 Wester Loan
Milnathort
Kinross
KY13 9YH

Single Survey

Date of inspection	7th May 2024
---------------------------	--------------

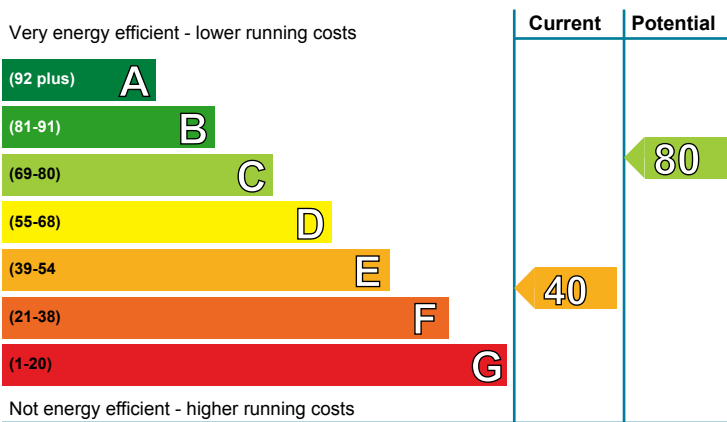
Energy Efficiency Rating

This graph shows the current efficiency of your home, taking into account both energy efficiency and fuel costs. The higher this rating, the lower your fuel bills are likely to be.

Your current rating is **band E (40)**. The average rating for EPCs in Scotland is **band D (61)**.

The potential rating shows the effect of undertaking all of the improvement measures listed within your recommendations report.

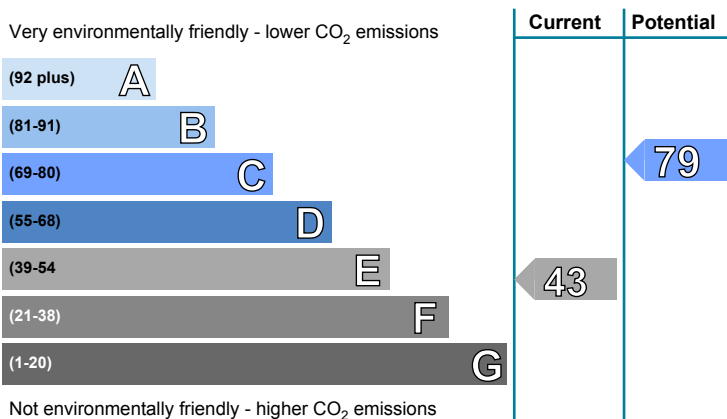
Environmental Impact (CO₂) Rating

This graph shows the effect of your home on the environment in terms of carbon dioxide (CO₂) emissions. The higher the rating, the less impact it has on the environment.
