HOME REPORT

Castleview
Wester Balgedie
Kinross
KY13 9HE

Single Survey

Property address	Castleview Wester Balgedie, Kinross, KY13 9HE
-------------------------	---

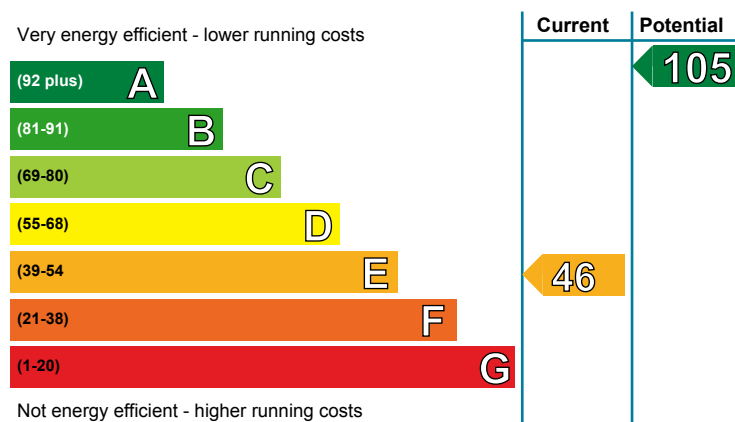
Energy Efficiency Rating

This graph shows the current efficiency of your home, taking into account both energy efficiency and fuel costs. The higher this rating, the lower your fuel bills are likely to be.

Your current rating is **band E (46)**. The average rating for EPCs in Scotland is **band D (61)**.

The potential rating shows the effect of undertaking all of the improvement measures listed within your recommendations report.

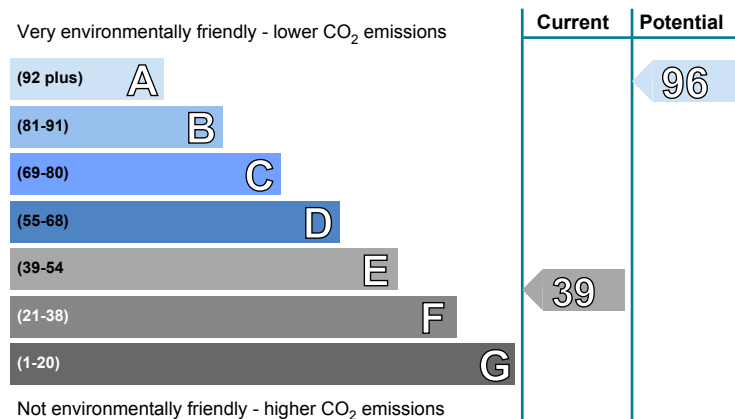
Environmental Impact (CO₂) Rating

This graph shows the effect of your home on the environment in terms of carbon dioxide (CO₂) emissions. The higher the rating, the less impact it has on the environment.
