HOME REPORT

32 Wester Loan
Milnathort
Kinross
KY13 9YH

Home Report Index

Single Survey

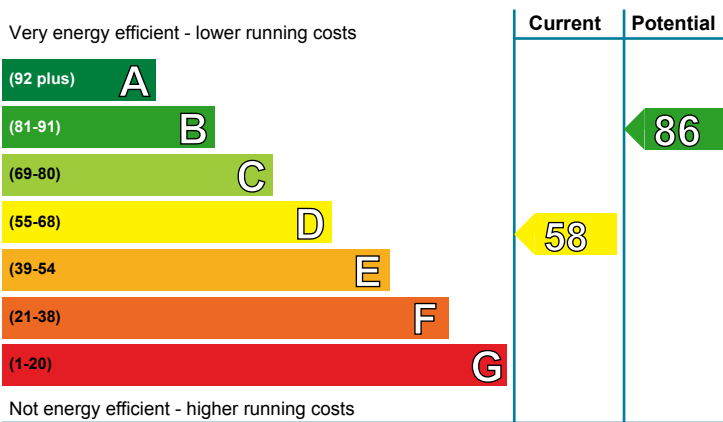
Energy Efficiency Rating

This graph shows the current efficiency of your home, taking into account both energy efficiency and fuel costs. The higher this rating, the lower your fuel bills are likely to be.

Your current rating is **band D (58)**. The average rating for EPCs in Scotland is **band D (61)**.

The potential rating shows the effect of undertaking all of the improvement measures listed within your recommendations report.

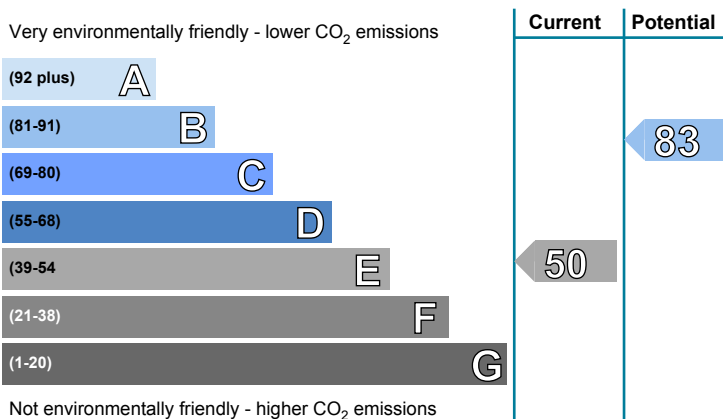
Environmental Impact (CO₂) Rating

This graph shows the effect of your home on the environment in terms of carbon dioxide (CO₂) emissions. The higher the rating, the less impact it has on the environment.
