HOME REPORT

Loch Glow
Main Street
Kinnesswood
Kinross
KY13 9HN

DM HALL
CHARTERED SURVEYORS

Single Survey

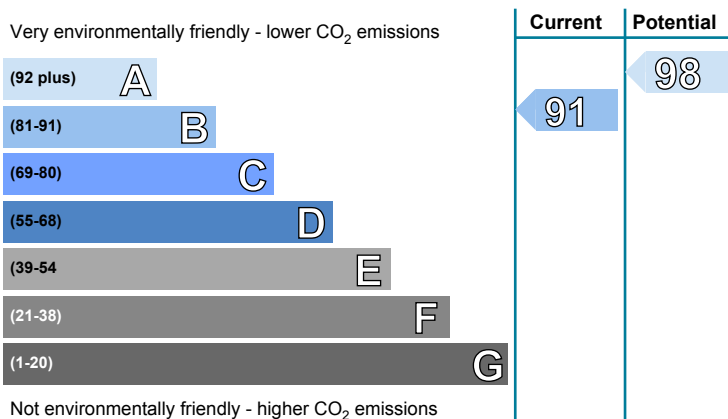
Environmental Impact (CO₂) Rating

This graph shows the effect of your home on the environment in terms of carbon dioxide (CO₂) emissions. The higher the rating, the less impact it has on the environment.
