HOME REPORT

Single Survey

Property address	12 Smith Street, Kinross, KY13 8DD
-------------------------	--

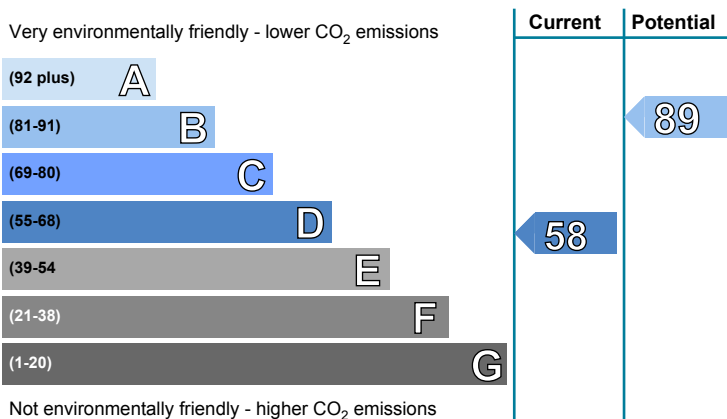
Environmental Impact (CO₂) Rating

This graph shows the effect of your home on the environment in terms of carbon dioxide (CO₂) emissions. The higher the rating, the less impact it has on the environment.
