HOME REPORT

23 Whinfield Drive
Kinross
KY13 8UB

Single Survey

Survey Report on:

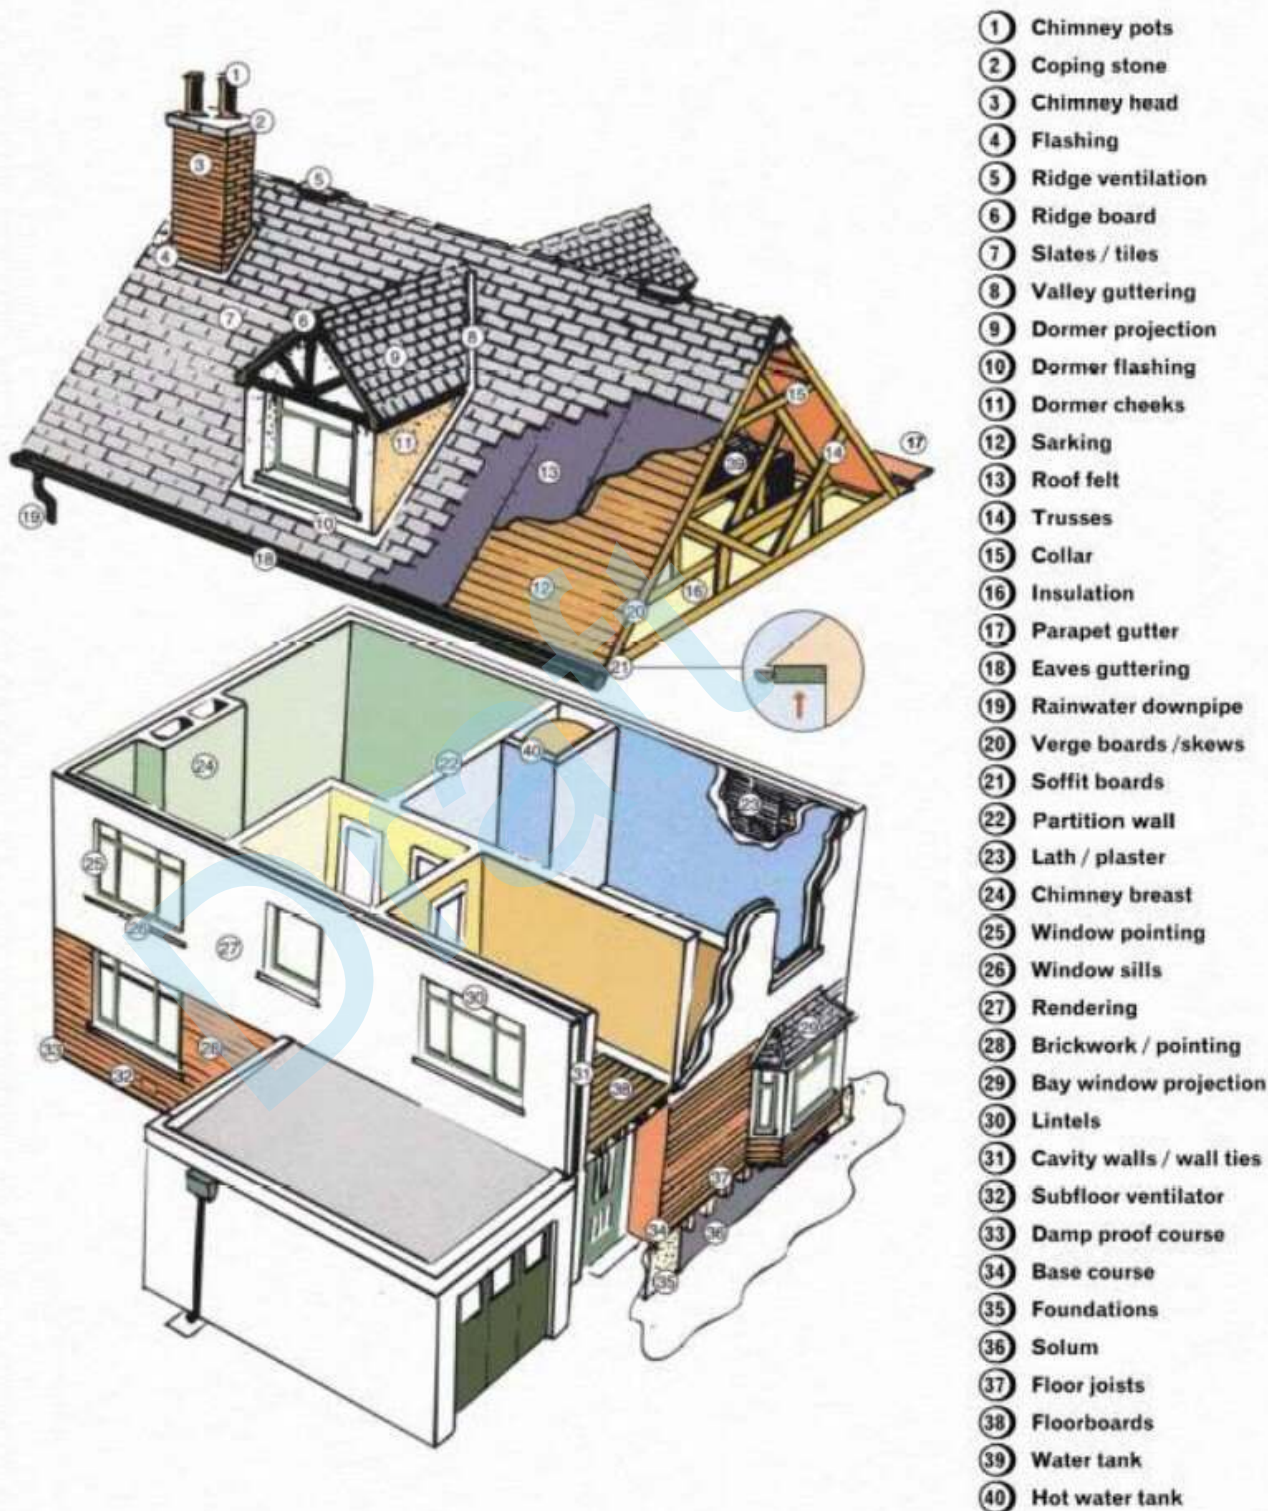
Sectional Diagram showing elements of a typical house

Reference may be made in this report to some or all of the above component parts of the property. This diagram may assist you in locating and understanding these items.
