# **HOME REPORT**

39 Sandport Kinross **KY13 8DN**

# Single Survey

# **Survey Report on:**

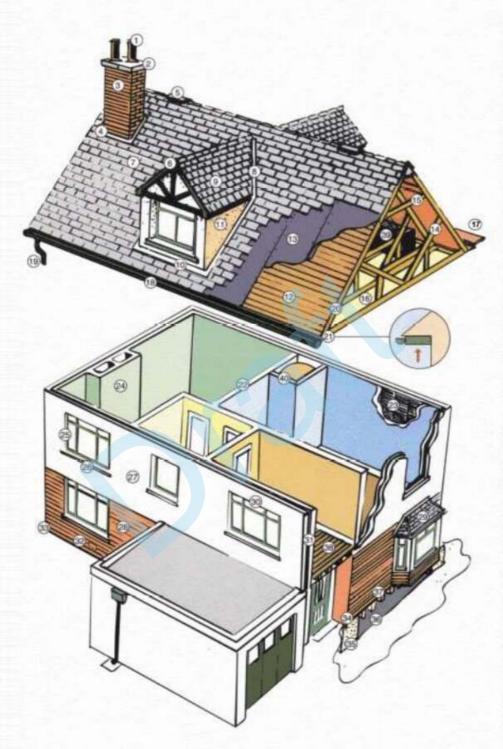
### Sectional Diagram showing elements of a typical house

Reference may be made in this report to some or all of the above component parts of the property. This diagram may assist you in locating and understanding these items.

- 1) Chimney pots
- (2) Coping stone
- 3) Chimney head
- (4) Flashing
- 5) Ridge ventilation
- (6) Ridge board
- (7) Slates / tiles
- (8) Valley guttering
- 9 Dormer projection
- 10) Dormer flashing
- 11) Dormer cheeks
- (12) Sarking
- (13) Roof felt
- (14) Trusses
- (15) Collar
- 16) Insulation
- (17) Parapet gutter
- 18) Eaves guttering
- a caves guttering
- (19) Rainwater downpipe
- 20) Verge boards /skews
- 21) Soffit boards
- 22) Partition wall
- 23 Lath / plaster
- (24) Chimney breast
- (25) Window pointing
- (26) Window sills
- (27) Rendering
- (28) Brickwork / pointing
- (29) Bay window projection
- (30) Lintels
- (31) Cavity walls / wall ties
- (32) Subfloor ventilator
- (33) Damp proof course
- 34) Base course
- 35 Foundations
- 36) Solum
- (37) Floor joists
- 38) Floorboards
- 39 Water tank
- 40) Hot water tank
