Home Report

Property: **8
Devorgilla Road
Dumfries
Dumfries And Galloway
DG1 3FJ**

Report reference: **1231041-1-2**

Date of Report: **31/08/2021**

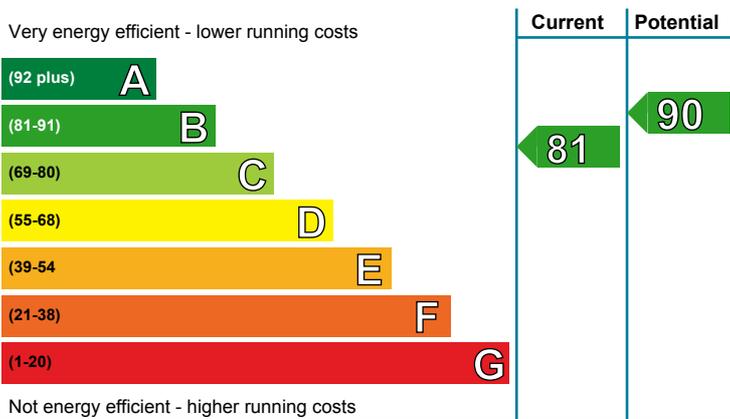
Energy Efficiency Rating

This graph shows the current efficiency of your home, taking into account both energy efficiency and fuel costs. The higher this rating, the lower your fuel bills are likely to be.

Your current rating is **band B (81)**. The average rating for EPCs in Scotland is **band D (61)**.

The potential rating shows the effect of undertaking all of the improvement measures listed within your recommendations report.

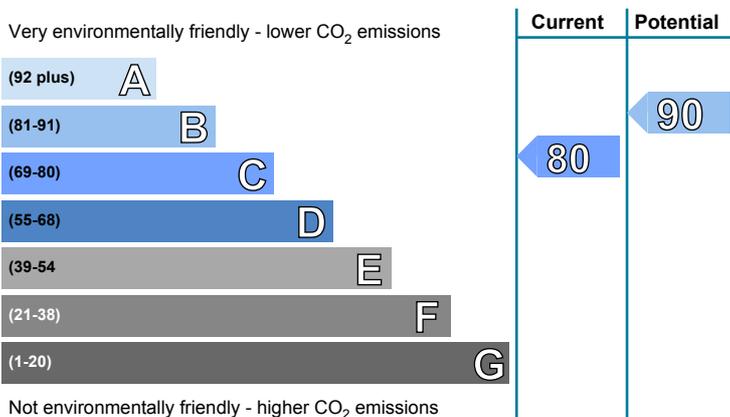
Environmental Impact (CO₂) Rating

This graph shows the effect of your home on the environment in terms of carbon dioxide (CO₂) emissions. The higher the rating, the less impact it has on the environment.

The potential rating shows the effect of undertaking all of the improvement measures listed within your recommendations report.
