# Home Report

Property: **52  
Eastfield Road  
Dumfries  
Dumfries And Galloway  
DG1 2EQ**

Report reference: **1261413-1-2**

Date of Report: **14/10/2021**

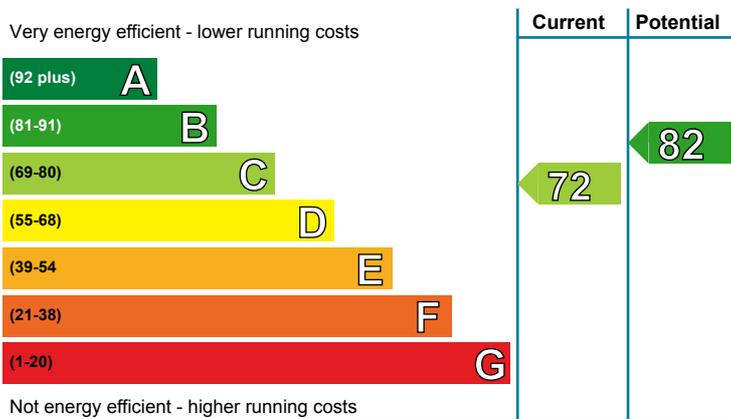
## Energy Efficiency Rating

This graph shows the current efficiency of your home, taking into account both energy efficiency and fuel costs. The higher this rating, the lower your fuel bills are likely to be.

Your current rating is **band C (72)**. The average rating for EPCs in Scotland is **band D (61)**.

The potential rating shows the effect of undertaking all of the improvement measures listed within your recommendations report.

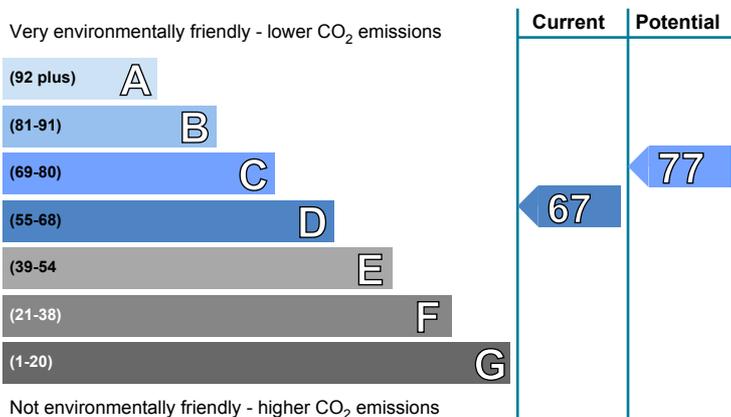
## Environmental Impact (CO<sub>2</sub>) Rating

This graph shows the effect of your home on the environment in terms of carbon dioxide (CO<sub>2</sub>) emissions. The higher the rating, the less impact it has on the environment.

The potential rating shows the effect of undertaking all of the improvement measures listed within your recommendations report.
