Home Report

Property: **Flat 2F
6 Glen Street
Edinburgh
Midlothian
EH3 9JF**

Report reference: **1256685-1-2**

Date of Report: **28/09/2021**

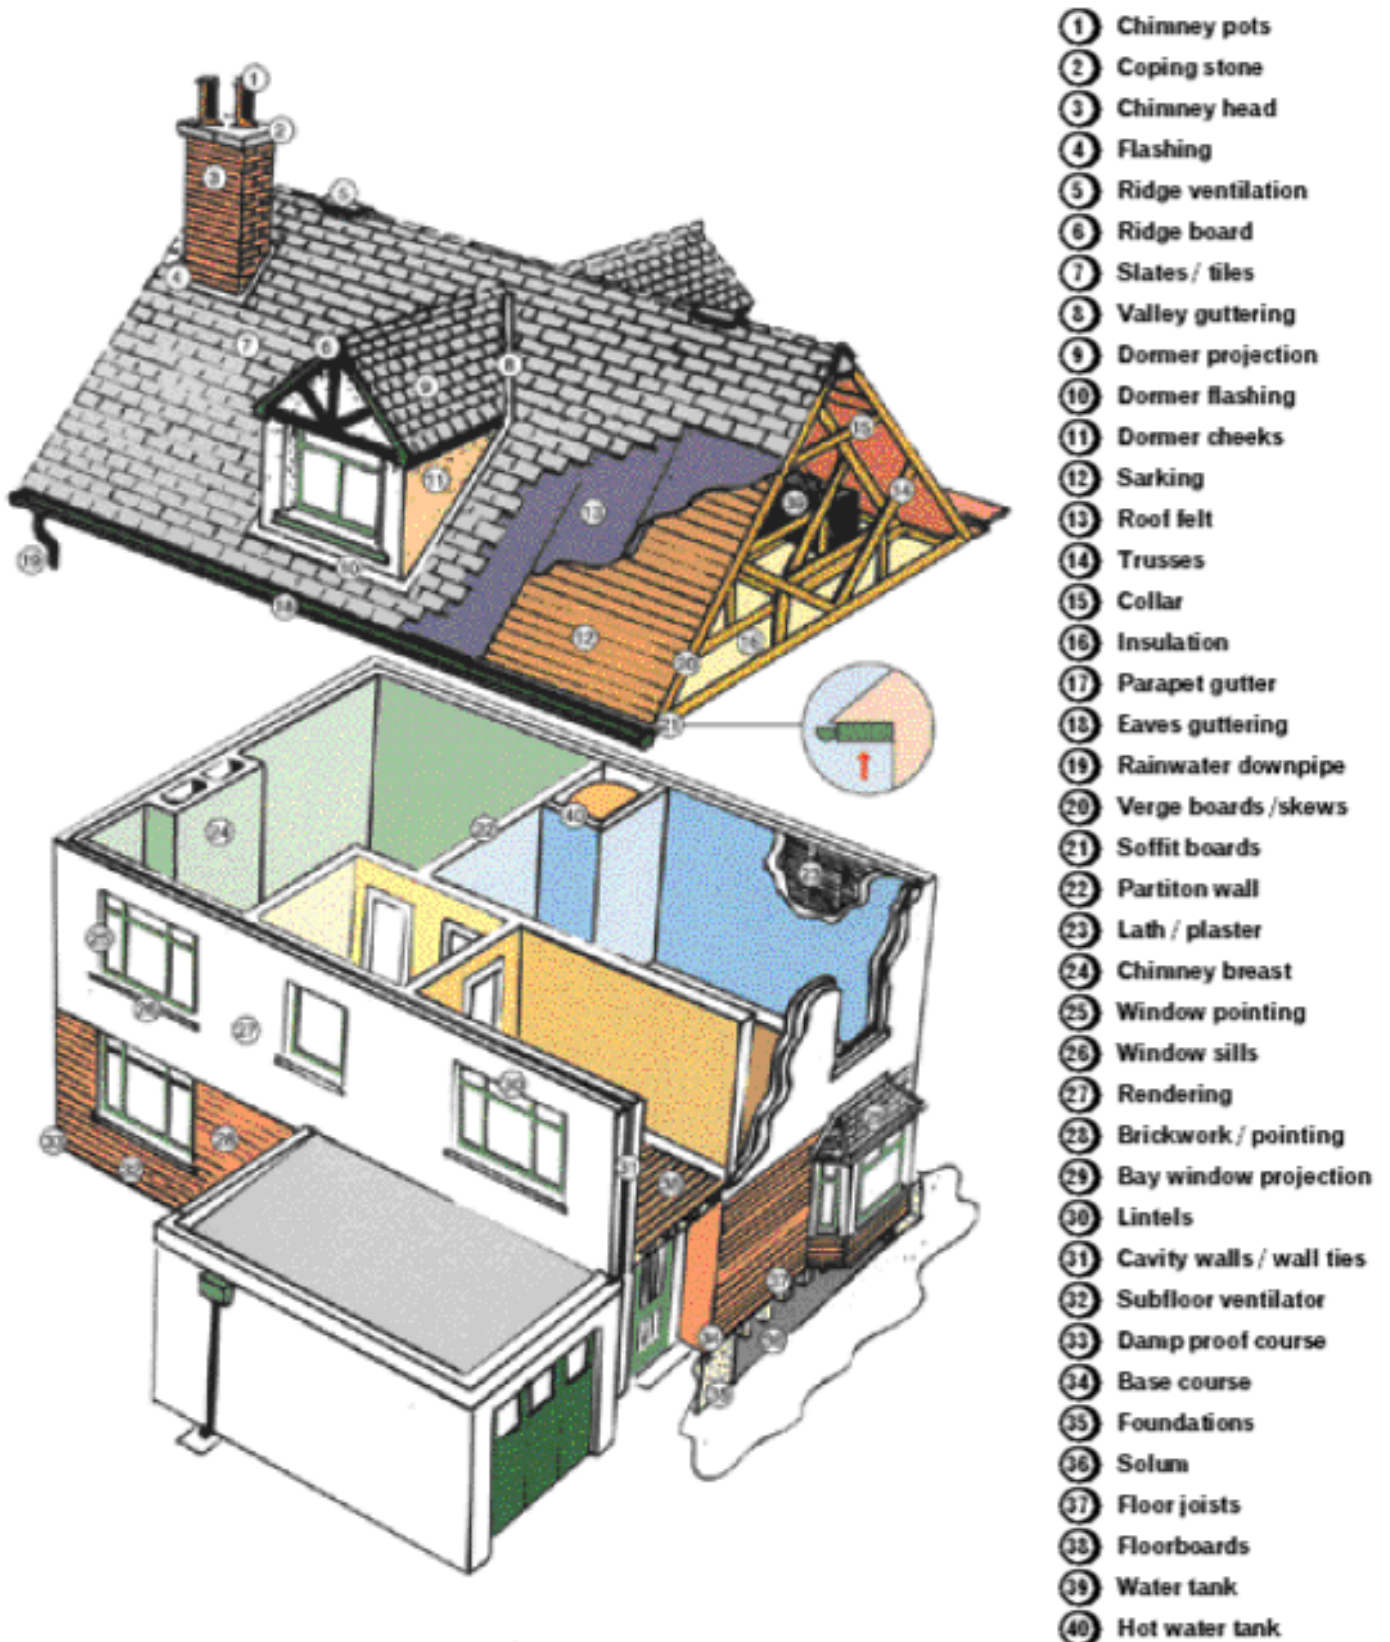
▷ Sectional diagram showing elements of a typical house:

- ① Chimney pots
- ② Coping stone
- ③ Chimney head
- ④ Flashing
- ⑤ Ridge ventilation
- ⑥ Ridge board
- ⑦ Slates / tiles
- ⑧ Valley guttering
- ⑨ Dormer projection
- ⑩ Dormer flashing
- ⑪ Dormer cheeks
- ⑫ Sarking
- ⑬ Roof felt
- ⑭ Trusses
- ⑮ Collar
- ⑯ Insulation
- ⑰ Parapet gutter
- ⑱ Eaves guttering
- ⑲ Rainwater downpipe
- ⑳ Verge boards /skews
- ㉑ Soffit boards
- ㉒ Partiton wall
- ㉓ Lath / plaster
- ㉔ Chimney breast
- ㉕ Window pointing
- ㉖ Window sills
- ㉗ Rendering
- ㉘ Brickwork / pointing
- ㉙ Bay window projection
- ㉚ Lintels
- ㉛ Cavity walls / wall ties
- ㉜ Subfloor ventilator
- ㉝ Damp proof course
- ㉞ Base course
- ㉟ Foundations
- ㊱ Solum
- ㊲ Floor joists
- ㊳ Floorboards
- ㊴ Water tank
- ㊵ Hot water tank

Reference may be made in this report to some or all of the above component parts of the property. This diagram may assist you in locating and understanding these terms.
