Home Report

Single Survey

Property address	0/2 31 Prince Edward Street Glasgow G42 8LU
Customer	Kishan Madhok
Customer address	0/2 31 Prince Edward Street Glasgow G42 8LU
Prepared by	Shepherd Chartered Surveyors
Date of inspection	08/01/2026

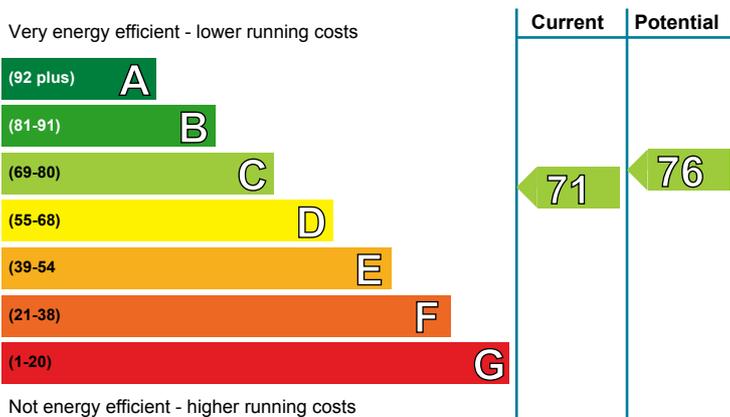
Energy Efficiency Rating

This graph shows the current efficiency of your home, taking into account both energy efficiency and fuel costs. The higher this rating, the lower your fuel bills are likely to be.

Your current rating is **band C (71)**. The average rating for EPCs in Scotland is **band D (61)**.

The potential rating shows the effect of undertaking all of the improvement measures listed within your recommendations report.

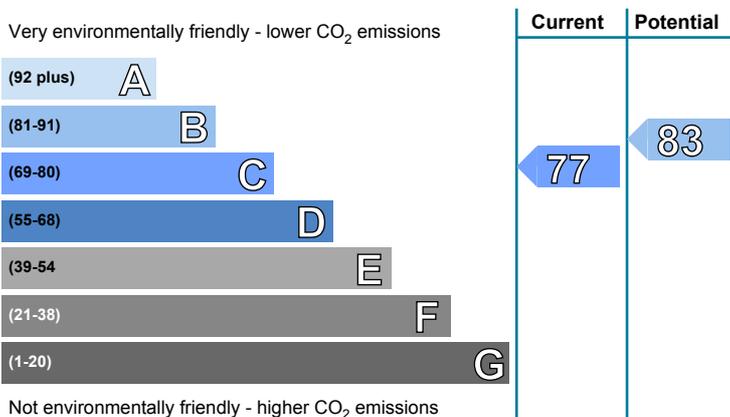
Environmental Impact (CO₂) Rating

This graph shows the effect of your home on the environment in terms of carbon dioxide (CO₂) emissions. The higher the rating, the less impact it has on the environment.
