Scottish Single Survey

Single Survey

Property address	1/2 5 Minard Road Glasgow G41 2HR
Customer	Lydia Kostopoulou
Customer address	1/2 5 Minard Road Glasgow G41 2HR
Prepared by	Shepherd Chartered Surveyors
Date of inspection	22/01/2026

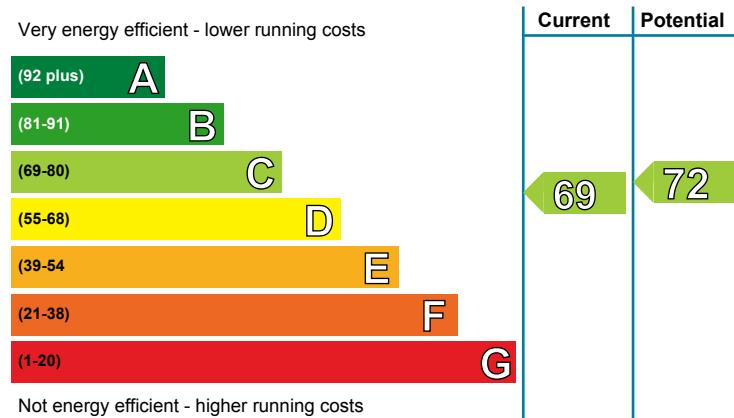
Energy Efficiency Rating

This graph shows the current efficiency of your home, taking into account both energy efficiency and fuel costs. The higher this rating, the lower your fuel bills are likely to be.

Your current rating is **band C (69)**. The average rating for EPCs in Scotland is **band D (61)**.

The potential rating shows the effect of undertaking all of the improvement measures listed within your recommendations report.

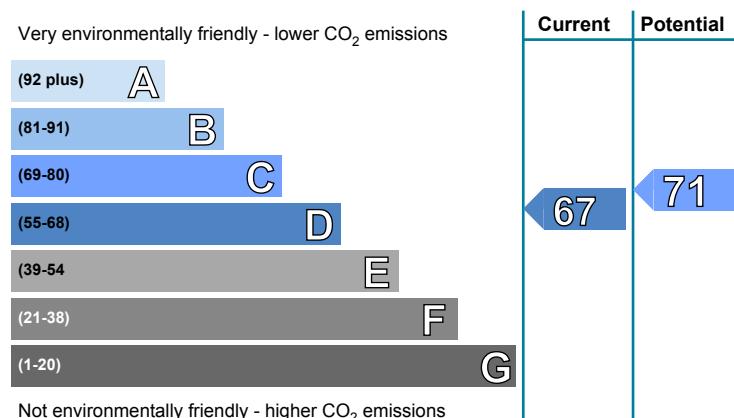
Environmental Impact (CO₂) Rating

This graph shows the effect of your home on the environment in terms of carbon dioxide (CO₂) emissions. The higher the rating, the less impact it has on the environment.
