HOME REPORT

Energy Performance Certificate (EPC)

66 CRATHIE DRIVE, GLENMAVIS, AIRDRIE, ML6 0ND

Single Survey

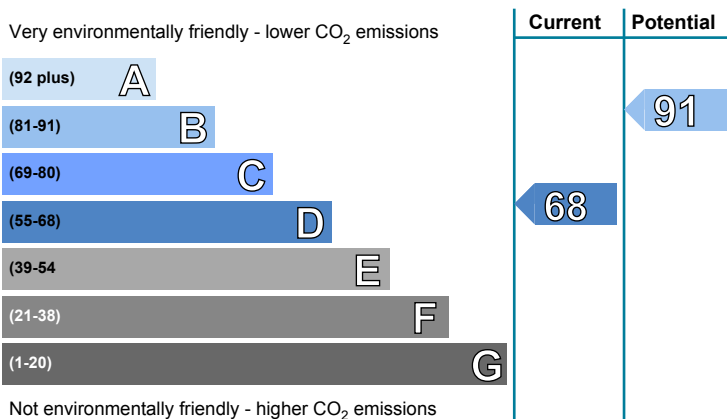
Environmental Impact (CO₂) Rating

This graph shows the effect of your home on the environment in terms of carbon dioxide (CO₂) emissions. The higher the rating, the less impact it has on the environment.

Your current rating is **band D (68)**. The average rating for EPCs in Scotland is **band D (59)**.

The potential rating shows the effect of undertaking all of the improvement measures listed within your recommendations report.
