# HOME REPORT

53 EAST ACADEMY STREET  
WISHAW  
ML2 8AZ

# Energy Performance Certificate (EPC)

53 EAST ACADEMY STREET, WISHAW, ML2 8AZ

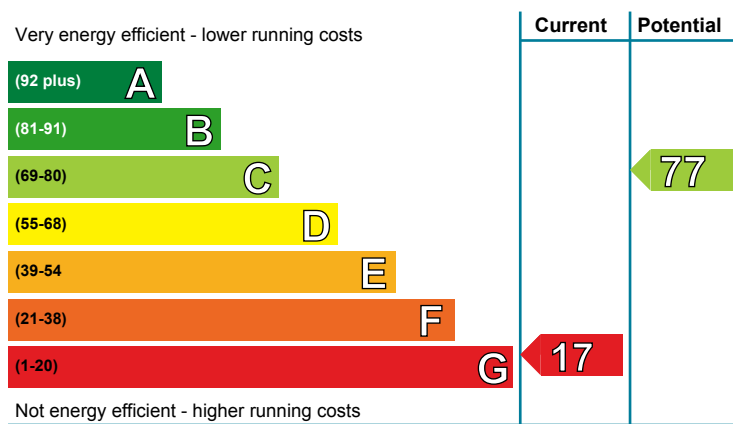
## Energy Efficiency Rating

This graph shows the current efficiency of your home, taking into account both energy efficiency and fuel costs. The higher this rating, the lower your fuel bills are likely to be.

Your current rating is **band G (17)**. The average rating for EPCs in Scotland is **band D (61)**.

The potential rating shows the effect of undertaking all of the improvement measures listed within your recommendations report.

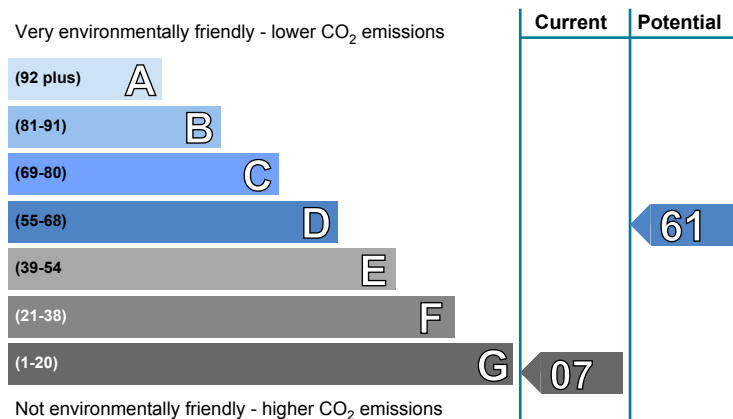
## Environmental Impact (CO<sub>2</sub>) Rating

This graph shows the effect of your home on the environment in terms of carbon dioxide (CO<sub>2</sub>) emissions. The higher the rating, the less impact it has on the environment.

Your current rating is **band G (7)**. The average rating for EPCs in Scotland is **band D (59)**.

The potential rating shows the effect of undertaking all of the improvement measures listed within your recommendations report.
