YOUR ONESURVEY HOME REPORT

25 Ladyacre Wynd Irvine KA11 2FY PREPARED FOR

Single Survey

Surveyor Reference	IV202503-21082
Customer	Mr & Mrs. Gordon & Lynzie Haggart
Selling address	25 Ladyacre Wynd
	Irvine
	KA11 2FY
Date of Inspection	02/04/2025
Prepared by	Greg Fisher, MRICS
	D M Hall - Irvine

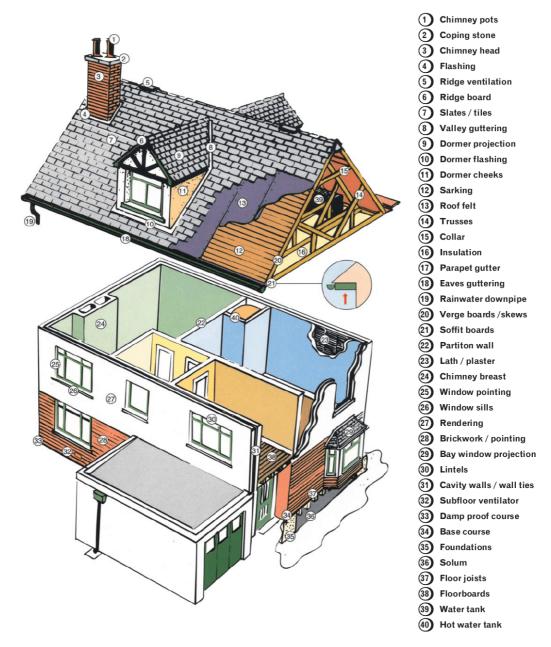
Sectional Diagram showing elements of a typical house

Reference may be made in this report to some or all of the above component parts of the property. This diagram may assist you in locating and understanding these items.
