# HOME REPORT

16 WADINGBURN ROAD  
WADINGBURN  
LASSWADE  
EH18 1HS

DM HALL  
CHARTERED SURVEYORS

# Single Survey

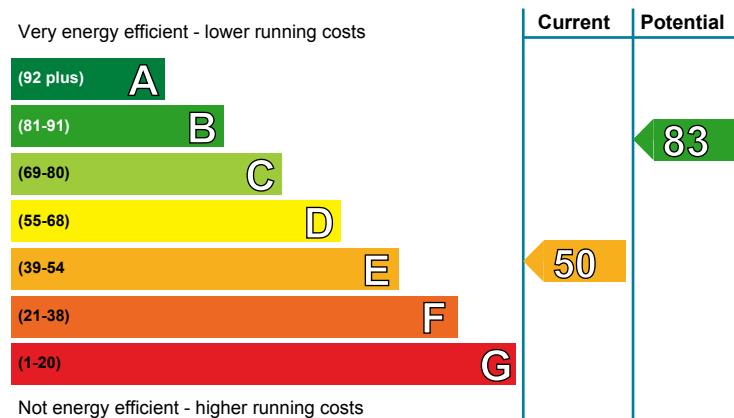
## Energy Efficiency Rating

This graph shows the current efficiency of your home, taking into account both energy efficiency and fuel costs. The higher this rating, the lower your fuel bills are likely to be.

Your current rating is **band E (50)**. The average rating for EPCs in Scotland is **band D (61)**.

The potential rating shows the effect of undertaking all of the improvement measures listed within your recommendations report.

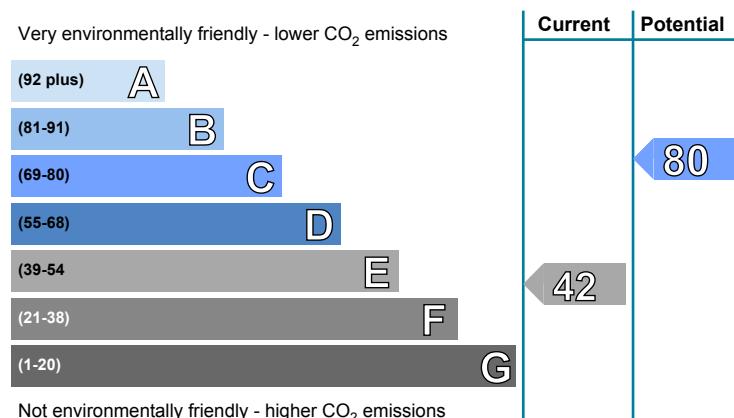
## Environmental Impact (CO<sub>2</sub>) Rating

This graph shows the effect of your home on the environment in terms of carbon dioxide (CO<sub>2</sub>) emissions. The higher the rating, the less impact it has on the environment.

Your current rating is **band E (42)**. The average rating for EPCs in Scotland is **band D (59)**.

The potential rating shows the effect of undertaking all of the improvement measures listed within your recommendations report.
