# **HOME REPORT**

85D NEW STREET FISHERROW MUSSELBURGH EH21 6DA

# survey report on:

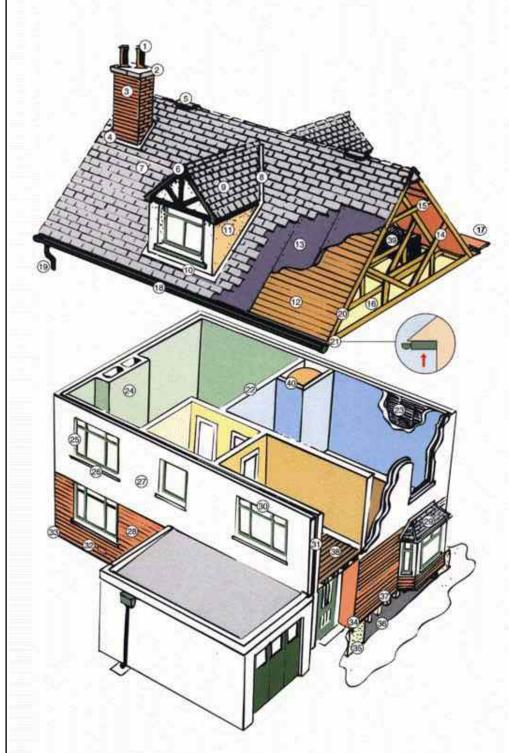
#### Sectional Diagram showing elements of a typical house

Reference may be made in this report to some or all of the above component parts of the property. This diagram may assist you in locating and understanding these items.

- 1) Chimney pots
- (2) Coping stone
- 3) Chimney head
- 4) Flashing
- 5) Ridge ventilation
- 6) Ridge board
- 7) Slates / tiles
- 8 Valley guttering
- 9) Dormer projection
- 10 Dormer flashing
- 11 Dormer cheeks
- 12) Sarking
- (13) Roof felt
- (14) Trusses
- 15) Collar
- (16) Insulation
- 7) Parapet gutter
- 18) Eaves guttering
- 19) Rainwater downpipe
- 0) Verge boards /skews
- 21) Soffit boards
- 22) Partition wall
- 23) Lath / plaster
- (24) Chimney breast
- (25) Window pointing
- 26) Window sills
- (27) Rendering
- (28) Brickwork / pointing
- 29) Bay window projection
- (30) Lintels
- (31) Cavity walls / wall ties
- 32) Subfloor ventilator
- 33) Damp proof course
- 34) Base course
- 35) Foundations
- (36) Solum
- 37) Floor joists
- 38) Floorboards
- 9) Water tank
- (40) Hot water tank
