HOME REPORT

45 HUNTERFIELD TERRACE
GOREBRIDGE
EH23 4BG

Energy Performance Certificate (EPC)

Dwelling type: Ground-floor flat
Date of assessment: 15 September 2023
Date of certificate: 19 September 2023
Total floor area: 78 m²
Primary Energy Indicator: 278 kWh/m²/year

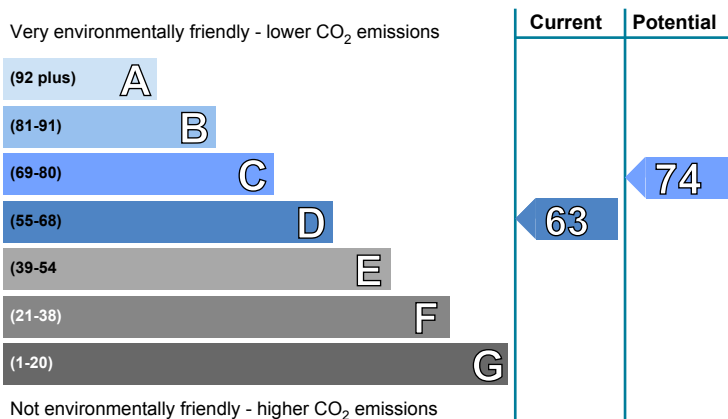
Environmental Impact (CO₂) Rating

This graph shows the effect of your home on the environment in terms of carbon dioxide (CO₂) emissions. The higher the rating, the less impact it has on the environment.

Your current rating is **band D (63)**. The average rating for EPCs in Scotland is **band D (59)**.

The potential rating shows the effect of undertaking all of the improvement measures listed within your recommendations report.
