HOME REPORT

FLAT 4
27 SANDPORT STREET
NORTH LEITH
EDINBURGH
EH6 6EP

Energy Performance Certificate (EPC)

FLAT 4 , 27 SANDPORT STREET, NORTH LEITH, EDINBURGH, EH6 6EP

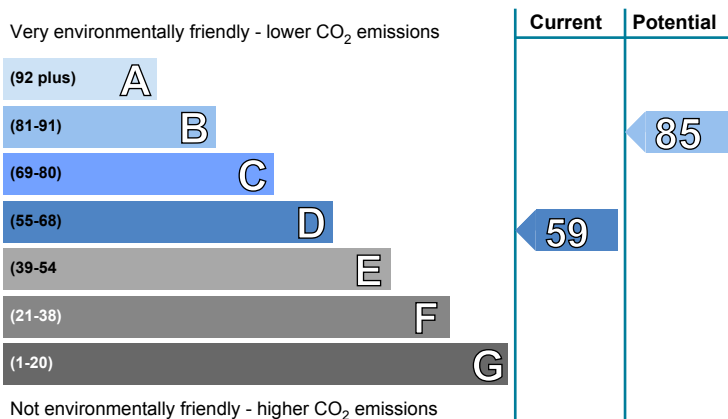
Environmental Impact (CO₂) Rating

This graph shows the effect of your home on the environment in terms of carbon dioxide (CO₂) emissions. The higher the rating, the less impact it has on the environment.

Your current rating is **band D (59)**. The average rating for EPCs in Scotland is **band D (59)**.

The potential rating shows the effect of undertaking all of the improvement measures listed within your recommendations report.
