# Single Survey

## Survey report on:

<b>Property Address</b>	8/4 Seafield Avenue Edinburgh EH6 7QG
<b>Customer</b>	Ms R Wilman
<b>Date of Inspection</b>	30/01/2025
<b>Prepared by</b>	D Grant Connells Survey & Valuation Ltd

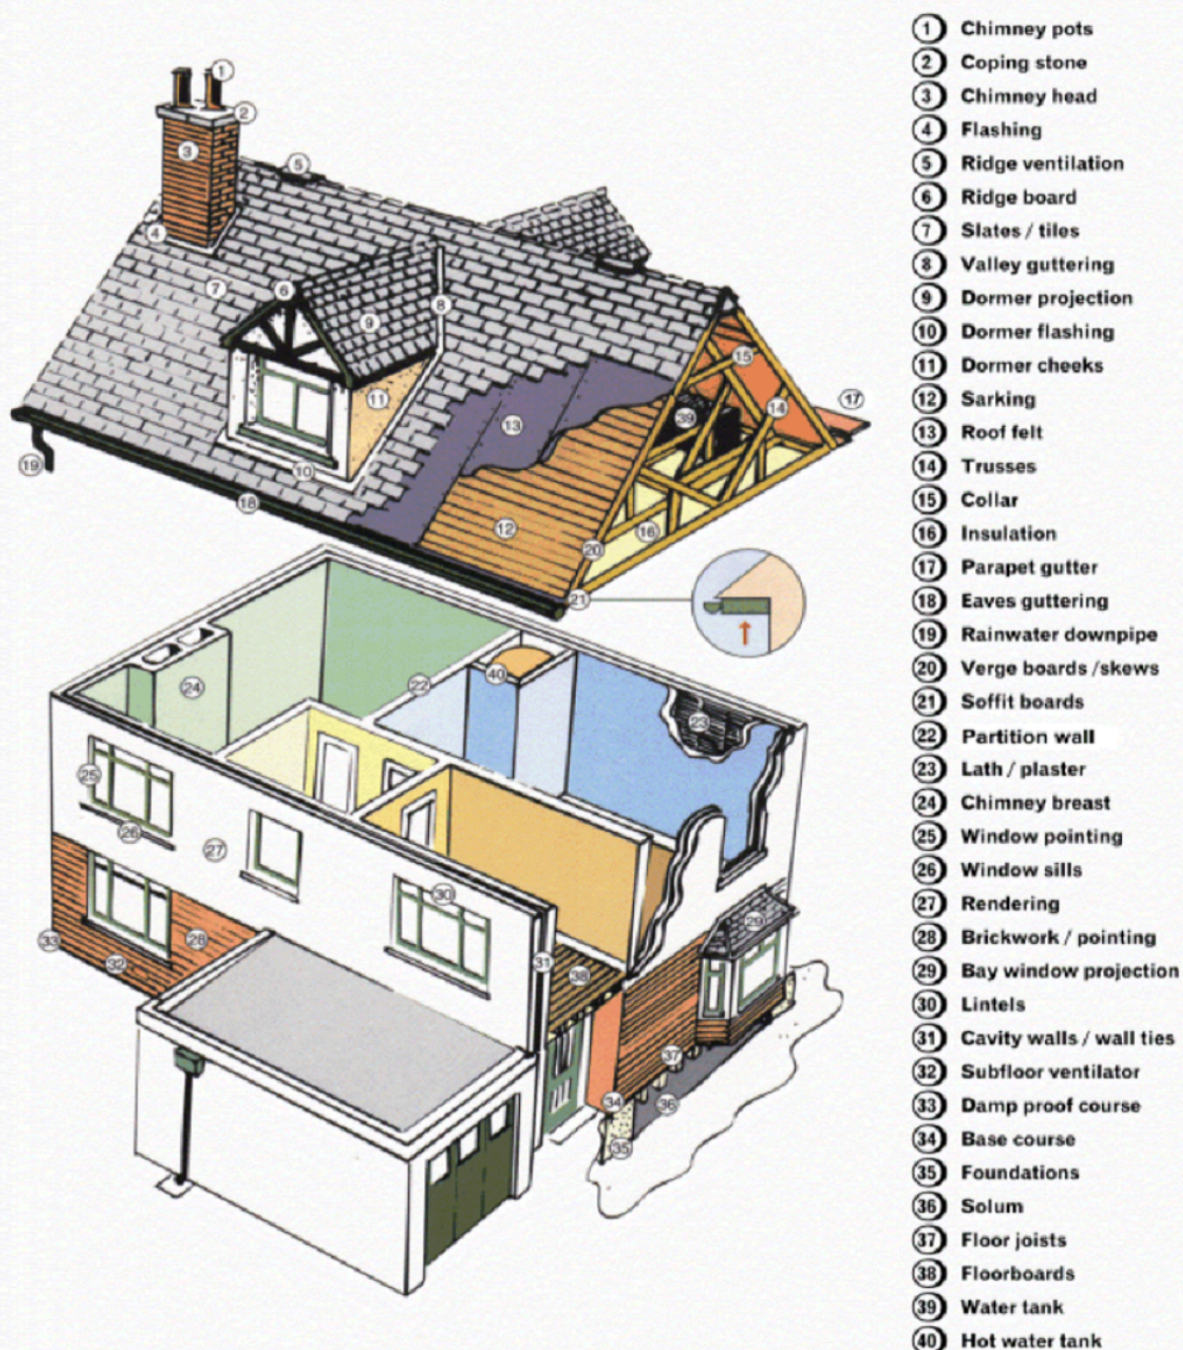
## Sectional Diagram showing elements of a typical house

Reference may be made in this report to some or all of the above component parts of the property. This diagram may assist you in locating and understanding these items.
