Home Report

Single Survey

Property Address	7 Abbey Grange, Newtongrange, Dalkeith, Midlothian, EH22 4RD
Reference	978241
Customer Name	Jack Allen
Date of Inspection	20th March 2025
Surveyor's name, qualifications and office	Eric Andrew BSc (Hons) MRICS DM Hall LLP Chartered Surveyors 17 Corstorphine Road Edinburgh EH12 6DD tel: 0131 624 6600 email: edinburghresidential@dmhall.co.uk
Prepared By	DM Hall LLP

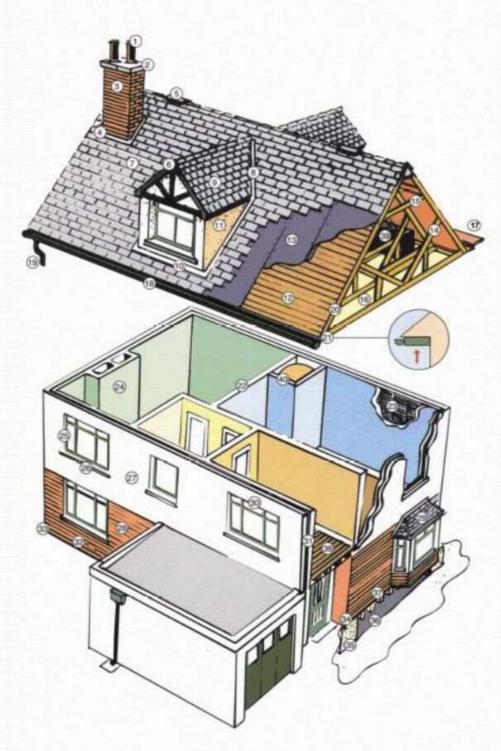
Sectional Diagram showing elements of a typical house

Reference may be made in this report to some or all of the above component parts of the property. This diagram may assist you in locating and understanding these items.

- 1) Chimney pots
- (2) Coping stone
- 3) Chimney head
- (4) Flashing
- 5 Ridge ventilation
- 6) Ridge board
- (7) Slates / tiles
- (8) Valley guttering
- 9 Dormer projection
- 10 Dormer flashing
- 11) Dormer cheeks
- (12) Sarking
- (13) Roof felt
- (14) Trusses
- (15) Collar
- (16) Insulation
- (17) Parapet gutter
- (18) Eaves guttering
- (19) Rainwater downpipe
- 20) Verge boards /skews
- (21) Soffit boards
- (22) Partition wall
- (23) Lath / plaster
- 24) Chimney breast
- (25) Window pointing
- Window sills
- (27) Rendering
- (28) Brickwork / pointing
- (29) Bay window projection
- (30) Lintels
- (31) Cavity walls / wall ties
- (32) Subfloor ventilator
- (33) Damp proof course
- 34) Base course
- 35) Foundations
- 36) Solum
- (37) Floor joists
- 38) Floorboards
- (39) Water tank
 - Hot water tank
