56 Woodburn Park, Dalkeith, Midlothian, EH22 2DB

Home Report

Single Survey

Property Address	56 Woodburn Park, Dalkeith, Midlothian, EH22 2DB
Reference	ER202504-24925
Customer Name	Jo Lithgow
Date of Inspection	5th May 2025
Surveyor's name, qualifications and office	Jonathan Hunter MSc, MRICS DM Hall LLP Chartered Surveyors 17 Corstorphine Road Edinburgh EH12 6DD tel: 0131 624 6600 email: edinburghresidential@dmhall.co.uk
Prepared By	DM Hall LLP

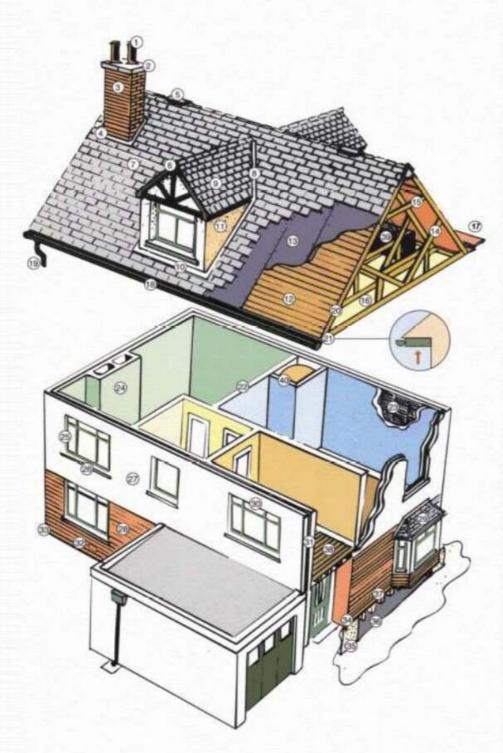
Sectional Diagram showing elements of a typical house

Reference may be made in this report to some or all of the above component parts of the property. This diagram may assist you in locating and understanding these items.

- 1) Chimney pots
- (2) Coping stone
- 3) Chimney head
- (4) Flashing
- (5) Ridge ventilation
- (6) Ridge board
- (7) Slates / tiles
- (8) Valley guttering
- 9 Dormer projection
- 10) Dormer flashing
- (11) Dormer cheeks
- (12) Sarking
- (13) Roof felt
- 14) Trusses
- Trusses
- 15) Collar
- 16 Insulation
- 17 Parapet gutter
- 18) Eaves guttering
- (19) Rainwater downpipe
- 20) Verge boards /skews
- 21) Soffit boards
- (22) Partition wall
- 23 Lath / plaster
- 24) Chimney breast
- (25) Window pointing
- (26) Window sills
- (27) Rendering
- (28) Brickwork / pointing
- (29) Bay window projection
- (30) Lintels
- (31) Cavity walls / wall ties
- (32) Subfloor ventilator
- (33) Damp proof course
- 34) Base course
- 35 Foundations
- 36) Solum
- (37) Floor joists
- 38) Floorboards
- 39) Water tank
- 10) Hot water tank
