27 Seafield Road,
Bilston,
Roslin,
Midlothian,
EH25 9RN

Home Report

Single Survey

Survey Report on:

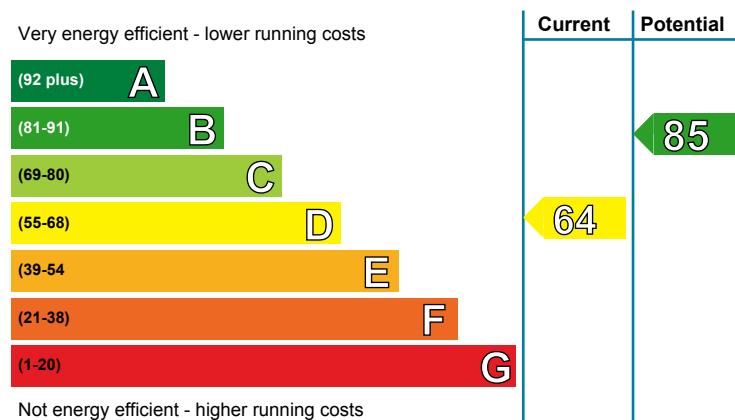
Energy Efficiency Rating

This graph shows the current efficiency of your home, taking into account both energy efficiency and fuel costs. The higher this rating, the lower your fuel bills are likely to be.

Your current rating is **band D (64)**. The average rating for EPCs in Scotland is **band D (61)**.

The potential rating shows the effect of undertaking all of the improvement measures listed within your recommendations report.

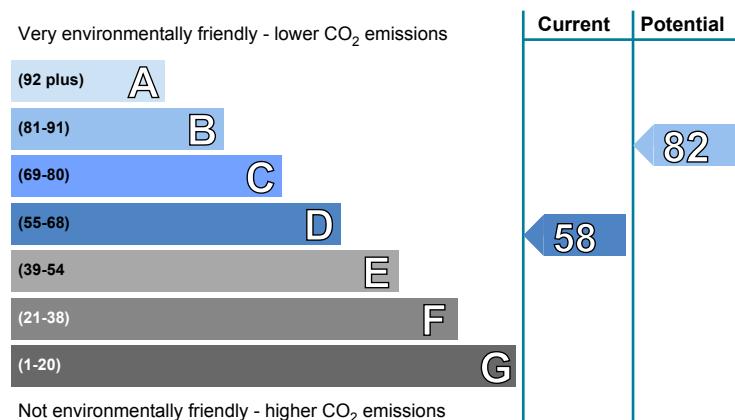
Environmental Impact (CO₂) Rating

This graph shows the effect of your home on the environment in terms of carbon dioxide (CO₂) emissions. The higher the rating, the less impact it has on the environment.
