Home Report

Single Survey

Property Address	7 Jubilee Crescent, Gorebridge, Midlothian, EH23 4XB
Reference	1269795
Customer Name	Mark Partridge
Date of Inspection	15th October 2025
Surveyor's name, qualifications and office	Eric R Andrew BSc (Hons) MRICS BSc (Hons) MRICS DM Hall LLP Chartered Surveyors 17 Corstorphine Road Edinburgh EH12 6DD tel: 0131 624 6600 email: edinburghresidential@dmhall.co.uk
Prepared By	DM Hall LLP

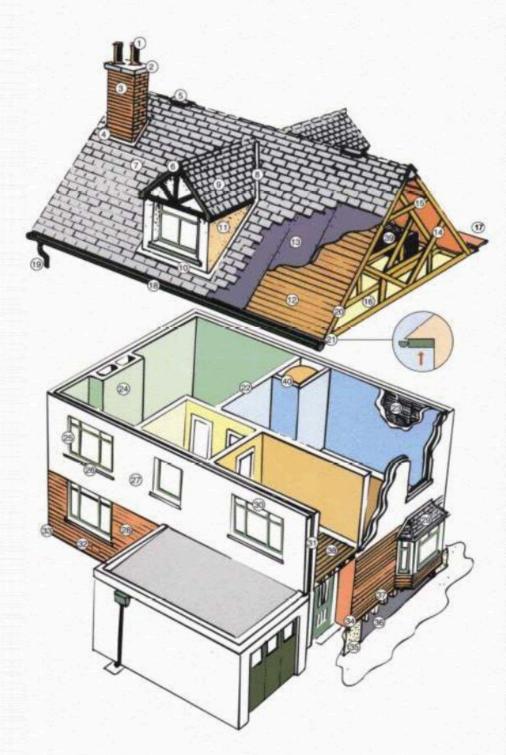
Sectional Diagram showing elements of a typical house

Reference may be made in this report to some or all of the above component parts of the property. This diagram may assist you in locating and understanding these items.

- 1) Chimney pots
- 2 Coping stone
- 3) Chimney head
- (4) Flashing
- (5) Ridge ventilation
- 6) Ridge board
- (7) Slates / tiles
- (8) Valley guttering
- 9 Dormer projection
- 10) Dormer flashing
- 11) Dormer cheeks
- (12) Sarking
- (13) Roof felt
- 3 -
- 14 Trusses
- (15) Collar
- (16) Insulation
- 17) Parapet gutter
- (18) Eaves guttering
- (19) Rainwater downpipe
- 20) Verge boards /skews
- (21) Soffit boards
- (22) Partition wall
- (23) Lath / plaster
- 24) Chimney breast
- (25) Window pointing
- (26) Window sills
- (27) Rendering
- (28) Brickwork / pointing
- (29) Bay window projection
- (30) Lintels
- (31) Cavity walls / wall ties
- (32) Subfloor ventilator
- (33) Damp proof course
- 34) Base course
- (35) Foundations
- 36) Solum
- (37) Floor joists
- 38) Floorboards
- 39) Water tank
- 0) Hot water tank
