# Home Report

2 Mcneill Avenue  
Prestwick  
KA9 2JX

# single survey

<b>Property address</b>	2 Mcneill Avenue Prestwick KA9 2JX
<b>Customer</b>	Marion Middleton
<b>Prepared by</b>	Graham + Sibbald LLP

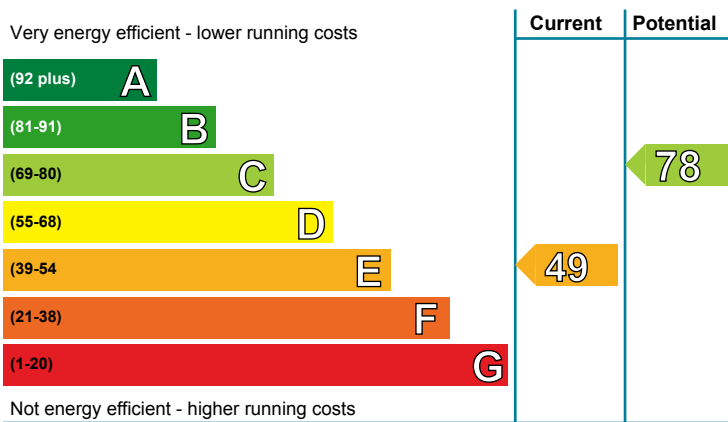
## Energy Efficiency Rating

This graph shows the current efficiency of your home, taking into account both energy efficiency and fuel costs. The higher this rating, the lower your fuel bills are likely to be.

Your current rating is **band E (49)**. The average rating for EPCs in Scotland is **band D (61)**.

The potential rating shows the effect of undertaking all of the improvement measures listed within your recommendations report.
