# Home Report

Charlotte House  
32 C Charlotte Street  
Ayr  
KA7 1EA

# single survey

<b>Property address</b>	Charlotte House 32 C Charlotte Street Ayr KA7 1EA
<b>Customer</b>	Michael Rankin
<b>Prepared by</b>	Graham + Sibbald LLP

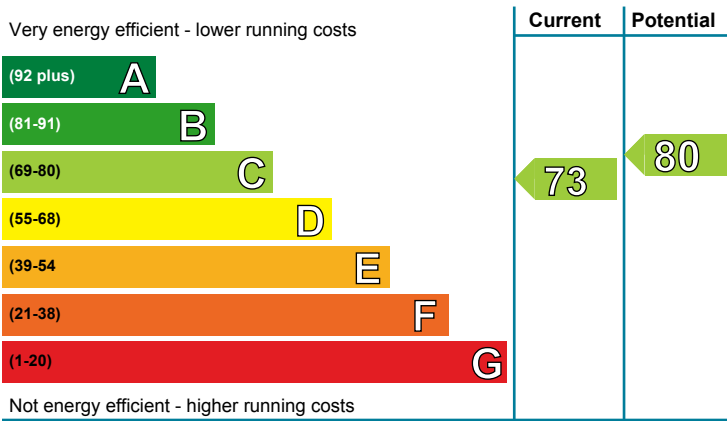
## Energy Efficiency Rating

This graph shows the current efficiency of your home, taking into account both energy efficiency and fuel costs. The higher this rating, the lower your fuel bills are likely to be.

Your current rating is **band C (73)**. The average rating for EPCs in Scotland is **band D (61)**.

The potential rating shows the effect of undertaking all of the improvement measures listed within your recommendations report.
