# Home Report

1 Redlands Road  
Glasgow G12 0SJ

# Single Survey

Property Address	1 Redlands Road Glasgow G12 0SJ
Customer	Kellee and Simon Lynch
Prepared by	Graham + Sibbald LLP
Date of Inspection	11/06/2025

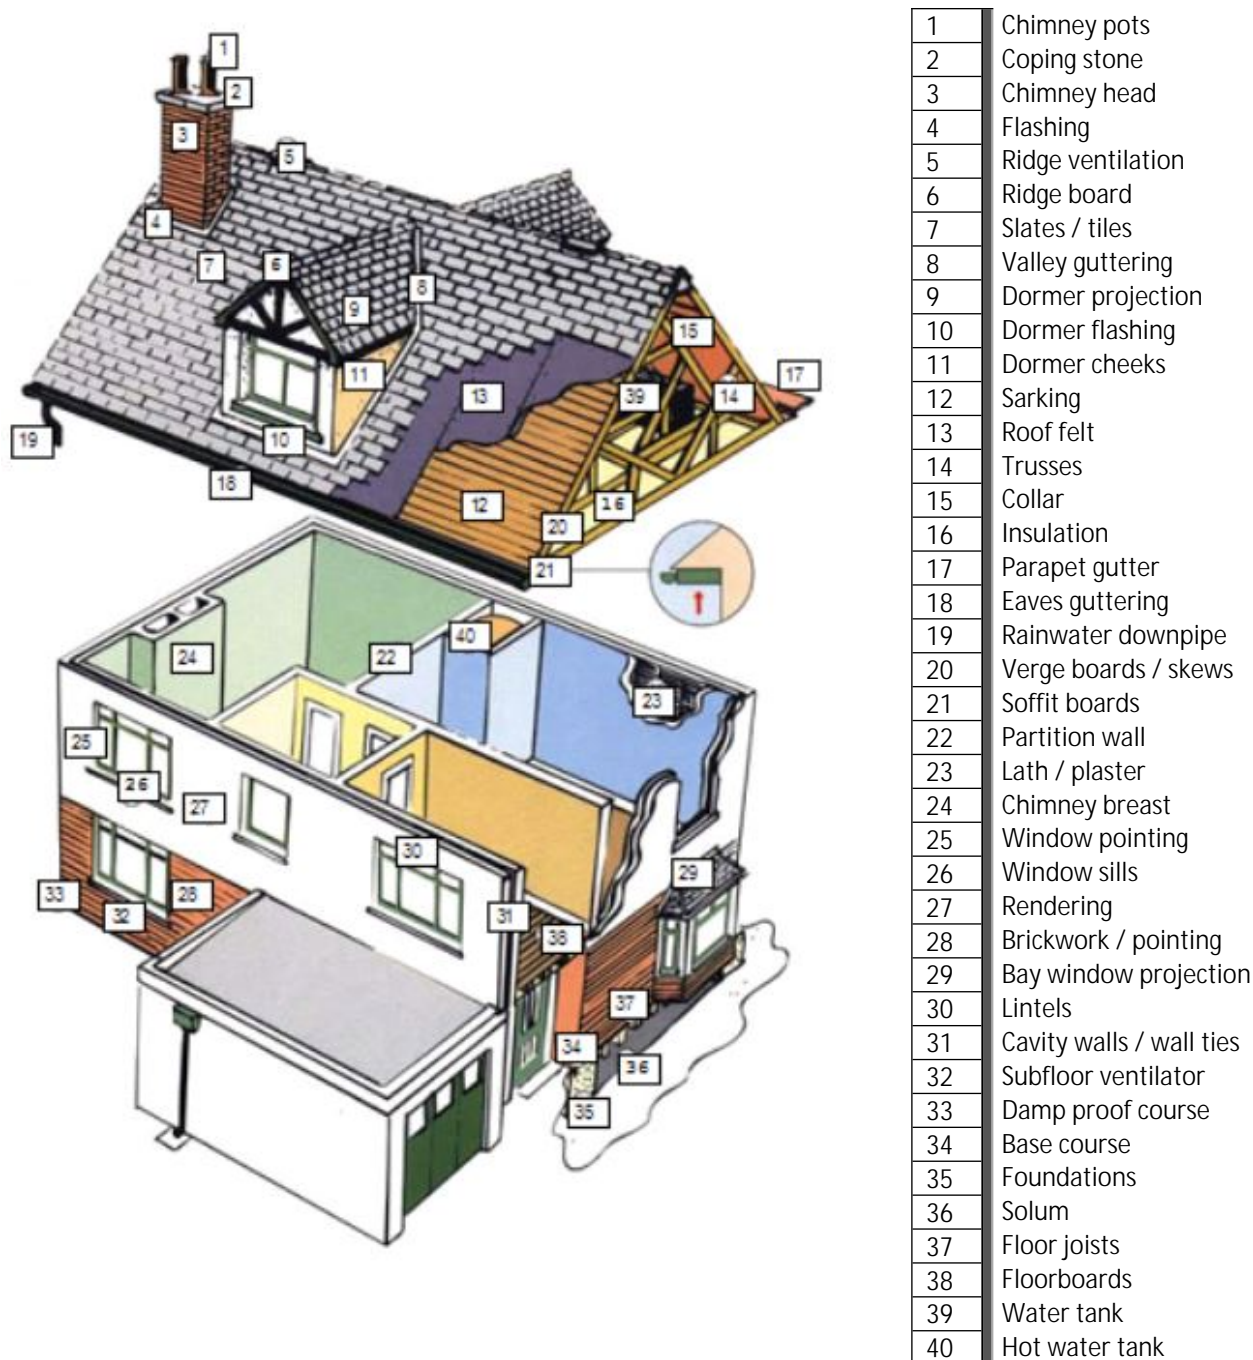
## Sectional diagram showing elements of a typical house

Reference may be made in this report to some or all of the above component parts of the property. This diagram may assist you in locating and understanding these items.
