# Home Report

1/4  
217 C King Street  
Broughty Ferry  
Dundee  
DD5 2AX

# single survey

<b>Property address</b>	1/4 217 C King Street Broughty Ferry Dundee DD5 2AX
<b>Customer</b>	George Coltart
<b>Prepared by</b>	Graham + Sibbald LLP

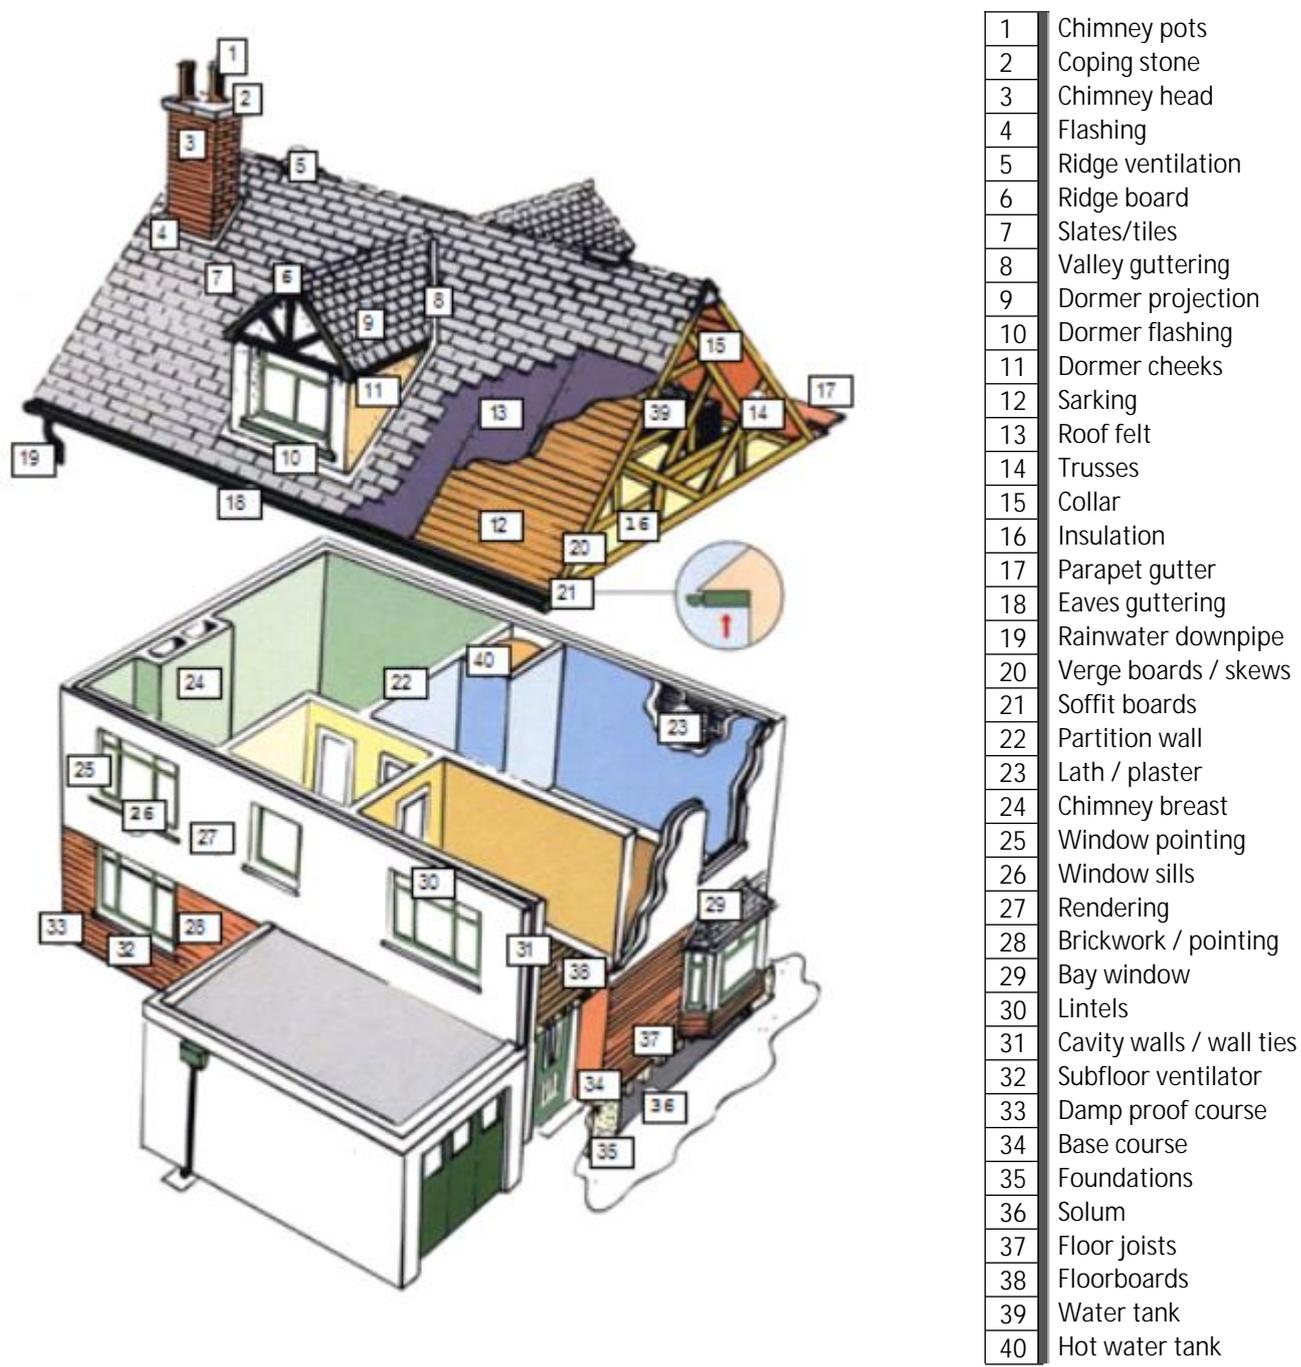
## Sectional Diagram showing elements of a typical house

Reference may be made in this report to some or all of the above component parts of the property. This diagram may assist you in locating and understanding these items.

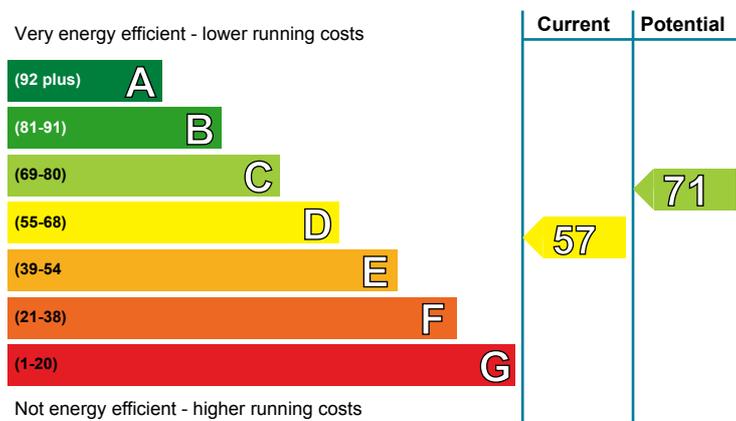
## Energy Efficiency Rating

This graph shows the current efficiency of your home, taking into account both energy efficiency and fuel costs. The higher this rating, the lower your fuel bills are likely to be.

Your current rating is **band D (57)**. The average rating for EPCs in Scotland is **band D (61)**.

The potential rating shows the effect of undertaking all of the improvement measures listed within your recommendations report.

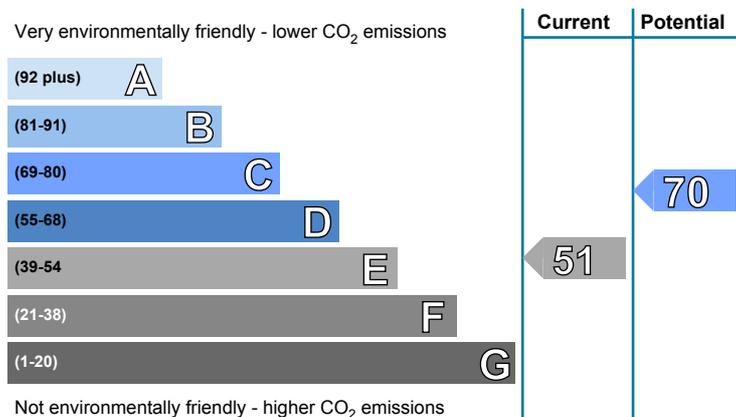
## Environmental Impact (CO<sub>2</sub>) Rating

This graph shows the effect of your home on the environment in terms of carbon dioxide (CO<sub>2</sub>) emissions. The higher the rating, the less impact it has on the environment.
