Home Report

5 C Reres Road
Broughty Ferry
Dundee
DD5 2QA

single survey

Property address	5 C Reres Road Broughty Ferry Dundee DD5 2QA
Customer	Gareth Hill and Andrew Grieveson
Prepared by	Graham + Sibbald LLP

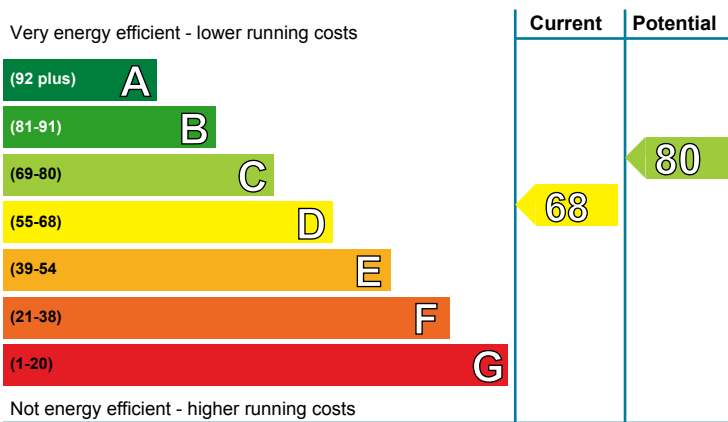
Energy Efficiency Rating

This graph shows the current efficiency of your home, taking into account both energy efficiency and fuel costs. The higher this rating, the lower your fuel bills are likely to be.

Your current rating is **band D (68)**. The average rating for EPCs in Scotland is **band D (61)**.

The potential rating shows the effect of undertaking all of the improvement measures listed within your recommendations report.

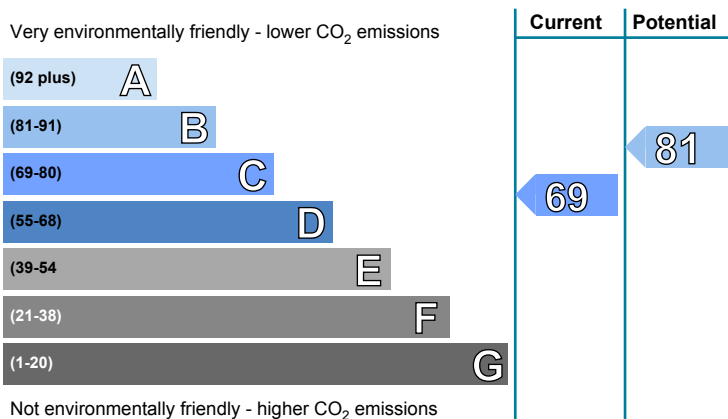
Environmental Impact (CO₂) Rating

This graph shows the effect of your home on the environment in terms of carbon dioxide (CO₂) emissions. The higher the rating, the less impact it has on the environment.
