Home Report

Blairhall House

single survey

Property address	Blairhall House . Old Balkello Dundee DD3 0QY
Customer	Leanne Couzens
Prepared by	Graham + Sibbald LLP

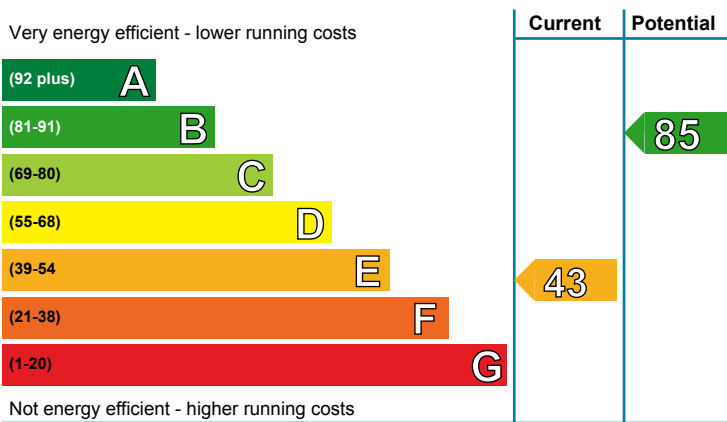
Energy Efficiency Rating

This graph shows the current efficiency of your home, taking into account both energy efficiency and fuel costs. The higher this rating, the lower your fuel bills are likely to be.

Your current rating is **band E (43)**. The average rating for EPCs in Scotland is **band D (61)**.

The potential rating shows the effect of undertaking all of the improvement measures listed within your recommendations report.

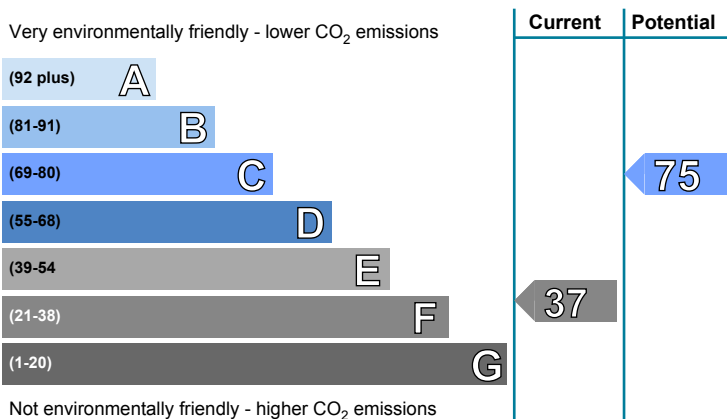
Environmental Impact (CO₂) Rating

This graph shows the effect of your home on the environment in terms of carbon dioxide (CO₂) emissions. The higher the rating, the less impact it has on the environment.
