Home Report

Netherton of Craigie Craigiebarn Road Dundee DD4 7PL

single survey

survey report on:

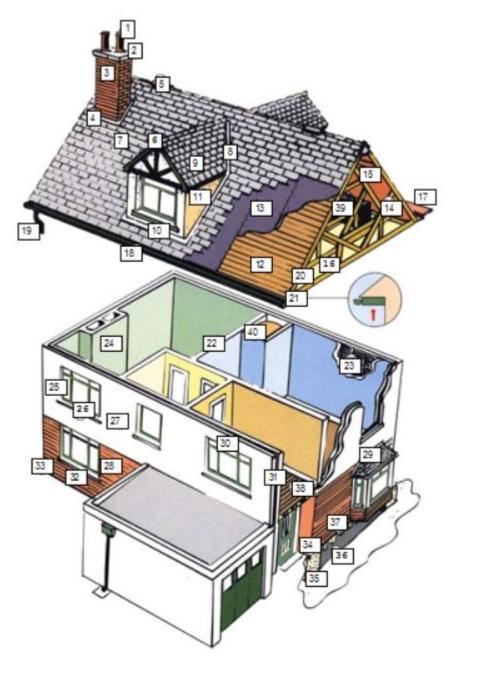
Sectional Diagram showing elements of a typical house

Reference may be made in this report to some or all of the above component parts of the property. This diagram may assist you in locating and understanding these items.

1	Chimney pots
2	Coping stone
3	Chimney head
4	Flashing
5	Ridge ventilation
6	Ridge board
6 7	Slates/tiles
8	Valley guttering
9	Dormer projection
10	Dormer flashing
11	Dormer cheeks
12	Sarking
13	Roof felt
14	Trusses
15	Collar
16	Insulation
17	Parapet gutter
18	Eaves guttering
19	Rainwater downpipe
20	Verge boards / skews
21	Soffit boards
22	Partition wall
23	Lath / plaster
24	Chimney breast
25	Window pointing
26	Window sills
27	Rendering
28	Brickwork / pointing
29	Bay window
30	Lintels
31	Cavity walls / wall ties
32	Subfloor ventilator
33	Damp proof course
34	Base course
35	Foundations
36	Solum
37	Floor joists
38	Floorboards
39	Water tank
40	Hot water tank
