# Home Report

10 Westhall Terrace  
Duntrune  
Dundee  
DD4 0SN

# single survey

## survey report on:

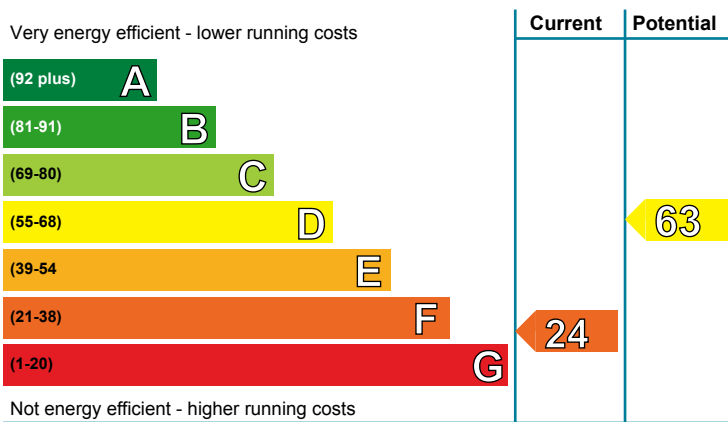
## Energy Efficiency Rating

This graph shows the current efficiency of your home, taking into account both energy efficiency and fuel costs. The higher this rating, the lower your fuel bills are likely to be.

Your current rating is **band F (24)**. The average rating for EPCs in Scotland is **band D (61)**.

The potential rating shows the effect of undertaking all of the improvement measures listed within your recommendations report.
