Home Report

Single Survey

Property address	15 Macalpine Place Dundee DD3 9BF
Customer	Mhairi Wallace
Customer address	15 Macalpine Place Dundee DD3 9BF
Prepared by	Shepherd Chartered Surveyors
Date of inspection	12/03/2024

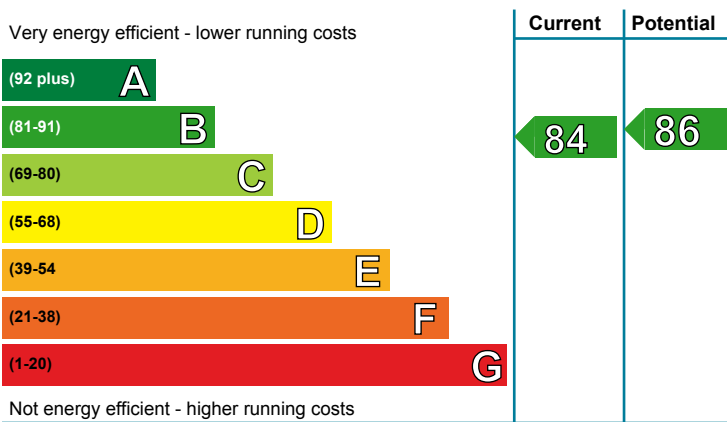
Energy Efficiency Rating

This graph shows the current efficiency of your home, taking into account both energy efficiency and fuel costs. The higher this rating, the lower your fuel bills are likely to be.

Your current rating is **band B (84)**. The average rating for EPCs in Scotland is **band D (61)**.

The potential rating shows the effect of undertaking all of the improvement measures listed within your recommendations report.
