Home Report

482 Riverside Drive Dundee DD1 4XB

single survey

survey report on:

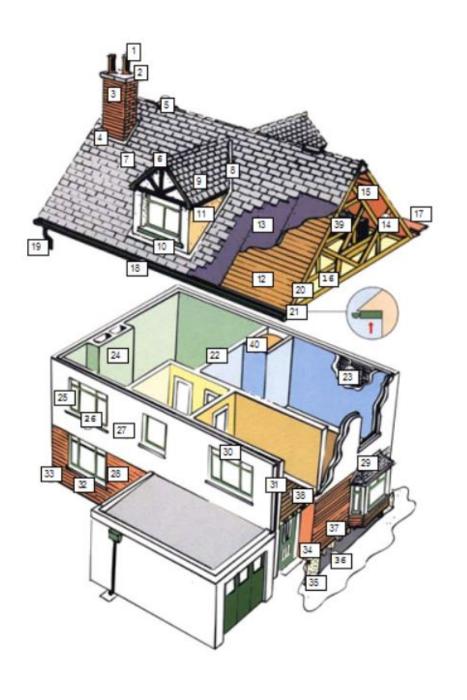
Sectional Diagram showing elements of a typical house

- Chimney pots
- 2 Coping stone
- 3 Chimney head
- Flashing 4
- Ridge ventilation
- Ridge board
- Slates/tiles
- Valley guttering 8
- Dormer projection 9
- 10 Dormer flashing
- 11 Dormer cheeks
- 12 Sarking
- Roof felt 13
- Trusses 14
- 15 Collar
- Insulation 16
- Parapet gutter 17
- Eaves guttering 18
- 19 Rainwater downpipe
- 20 Verge boards / skews
- Soffit boards 21
- Partition wall 22
- Lath / plaster 23
- 24 Chimney breast
- 25 Window pointing
- Window sills 26
- Rendering 27
- Brickwork / pointing 28
- window Bay 29
 - projection
- 30 Lintels
- Cavity walls / wall ties 31
- Subfloor ventilator 32
- Damp proof course 33
- Base course 34
- 35 **Foundations**
- Solum 36
- 37 Floor joists 38 Floorboards
- 39 Water tank
- 40 Hot water tank

Reference may be made in this report to some or all of the above component parts of the property. This diagram may assist you in locating and understanding these items.
