Home Report

83 Brook Street
Monifieth Dundee DD5 4AJ

Date of Valuation: 13/06/2024

Property address	83 Brook Street Dundee DD5 4AJ
Customer	Rachael Irvine & Fraser Cairns
Prepared by	Graham + Sibbald LLP

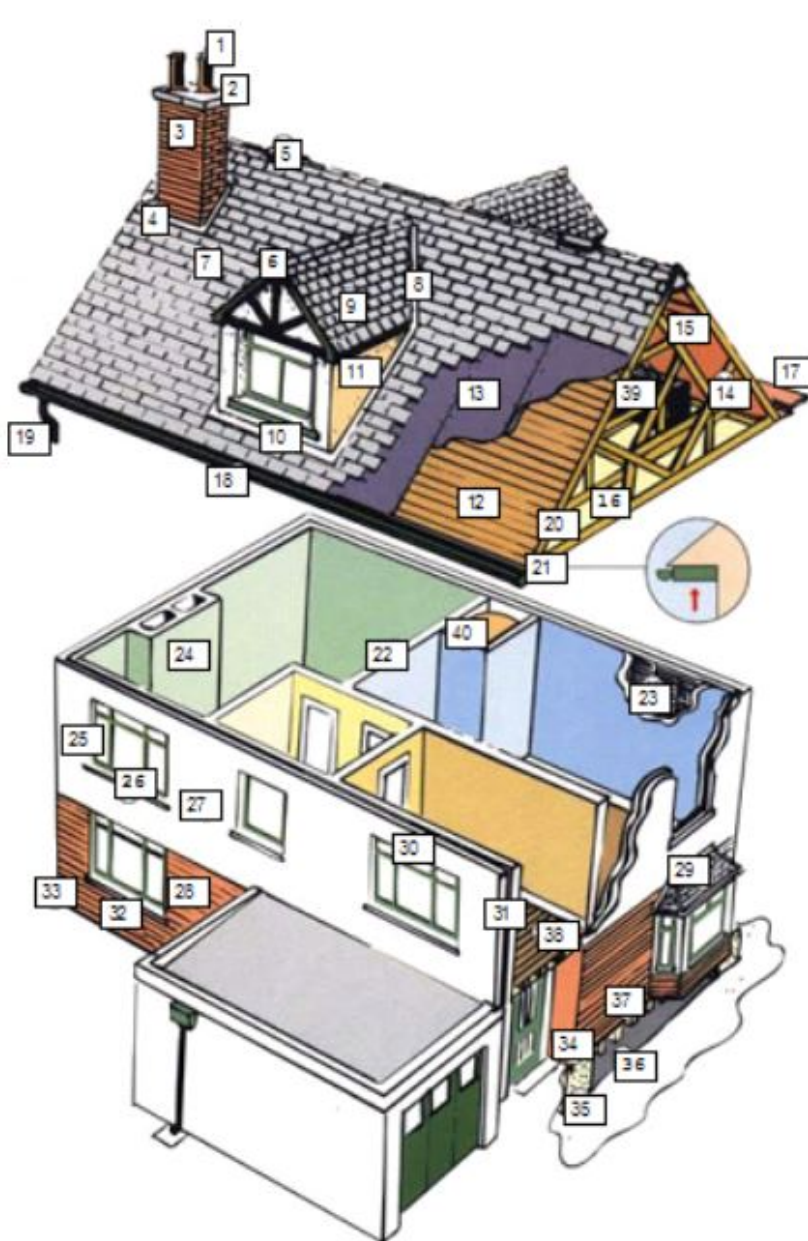
Sectional Diagram showing elements of a typical house

1	Chimney pots
2	Coping stone
3	Chimney head
4	Flashing
5	Ridge ventilation
6	Ridge board
7	Slates/tiles
8	Valley guttering
9	Dormer projection
10	Dormer flashing
11	Dormer cheeks
12	Sarking
13	Roof felt
14	Trusses
15	Collar
16	Insulation
17	Parapet gutter
18	Eaves guttering
19	Rainwater downpipe
20	Verge boards / skewes
21	Soffit boards
22	Partition wall
23	Lath / plaster
24	Chimney breast
25	Window pointing
26	Window sills
27	Rendering
28	Brickwork / pointing
29	Bay window projection
30	Lintels
31	Cavity walls / wall ties
32	Subfloor ventilator
33	Damp proof course
34	Base course
35	Foundations
36	Solum
37	Floor joists
38	Floorboards
39	Water tank
40	Hot water tank

Reference may be made in this report to some or all of the above component parts of the property. This diagram may assist you in locating and understanding these items.
